Phase I Geoenvironmental Site Assessment
Ryebank Road
Manchester,
Chorlton
Reference:13-533-R1-2
Date: March 2020

PHASE I GEOENVIRONMENTAL SITE ASSESSMENT

Ryebank Road,
Manchester,
Chorlton
M21 9LU

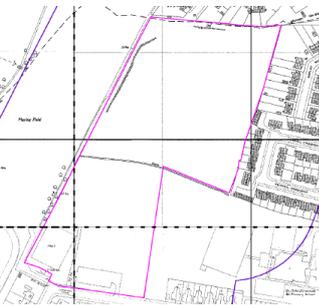
<p>1980-1984 1:10,000</p>	<p>A building is present along the western boundary of the site.</p>

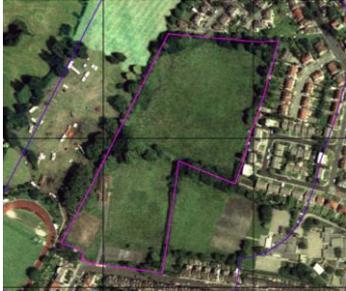
<p>2006 1:10,000</p>	<p>No significant changes to site.</p>

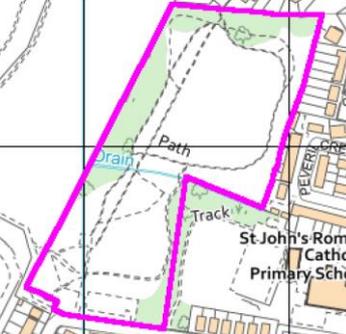
<p>2019 1:10,000</p>	<p>The building in the south west of the site is no longer present. Areas of woodland are present along the boundaries of the site, with a number of paths dissecting across the site.</p>

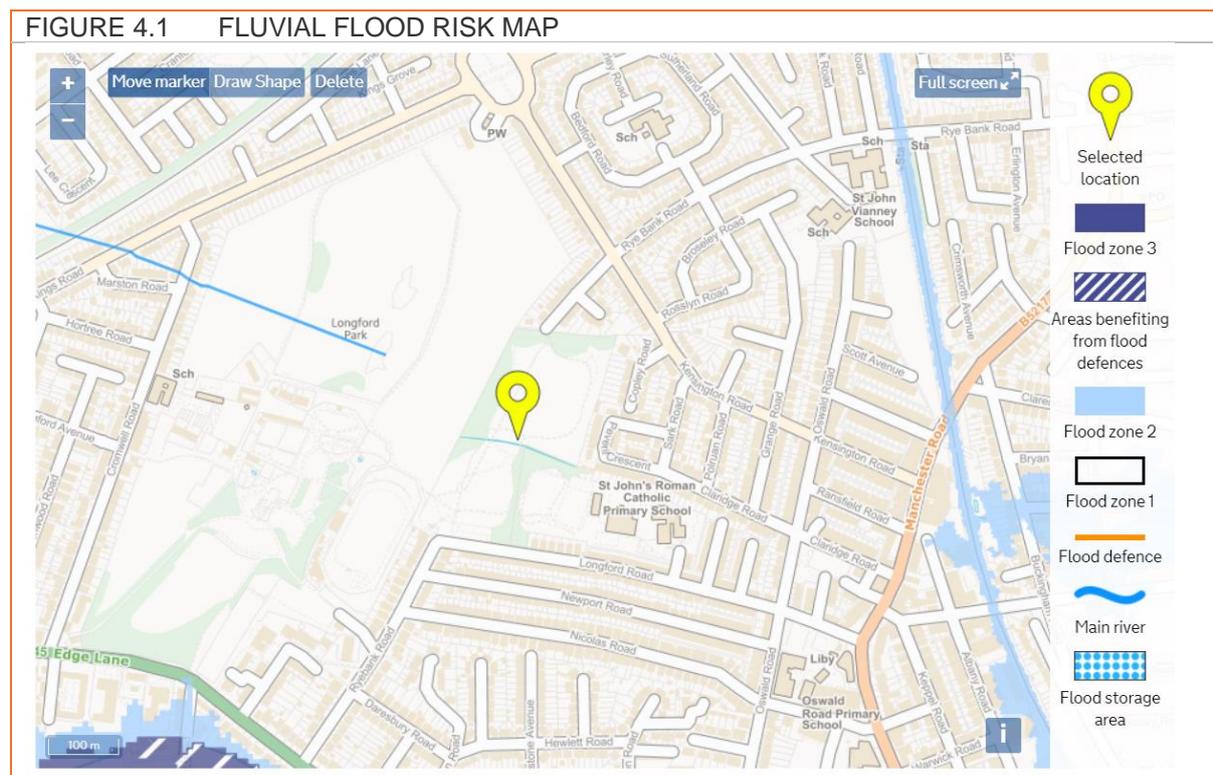
The Fluvial Flood Risk Map is presented in Figure 4.1.

An Environmental Constraints Plan provided by WSP Parsons Brinckerhoff (Reference 70014100, dated September 2015) has noted that the north of the site is at risk of potential reservoir flooding from the Audenshaw (1, 2 and 3) and Gorton Upper reservoirs however they have determined that this does not limit the development.

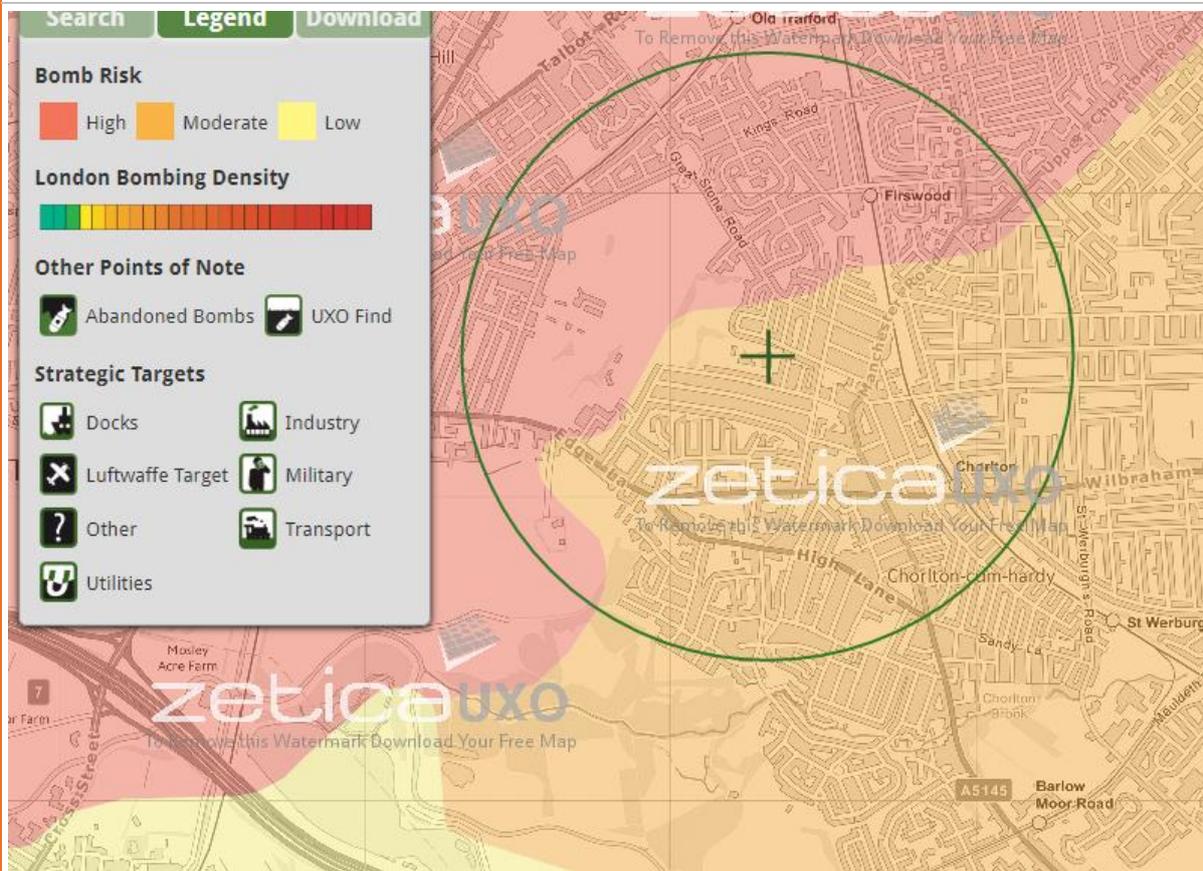
FIGURE 4.2 ZETICA UXO RISKS MAP

Preliminary and detailed UXO risk assessments have been completed for the subject site and amended to this report.

The recommended risk mitigation measures include UXO safety awareness briefings prior to all intrusive works, on-site supervision with EOD engineer during all site investigation works and open excavations, and intrusive magnetometer probe survey for all pile positions.

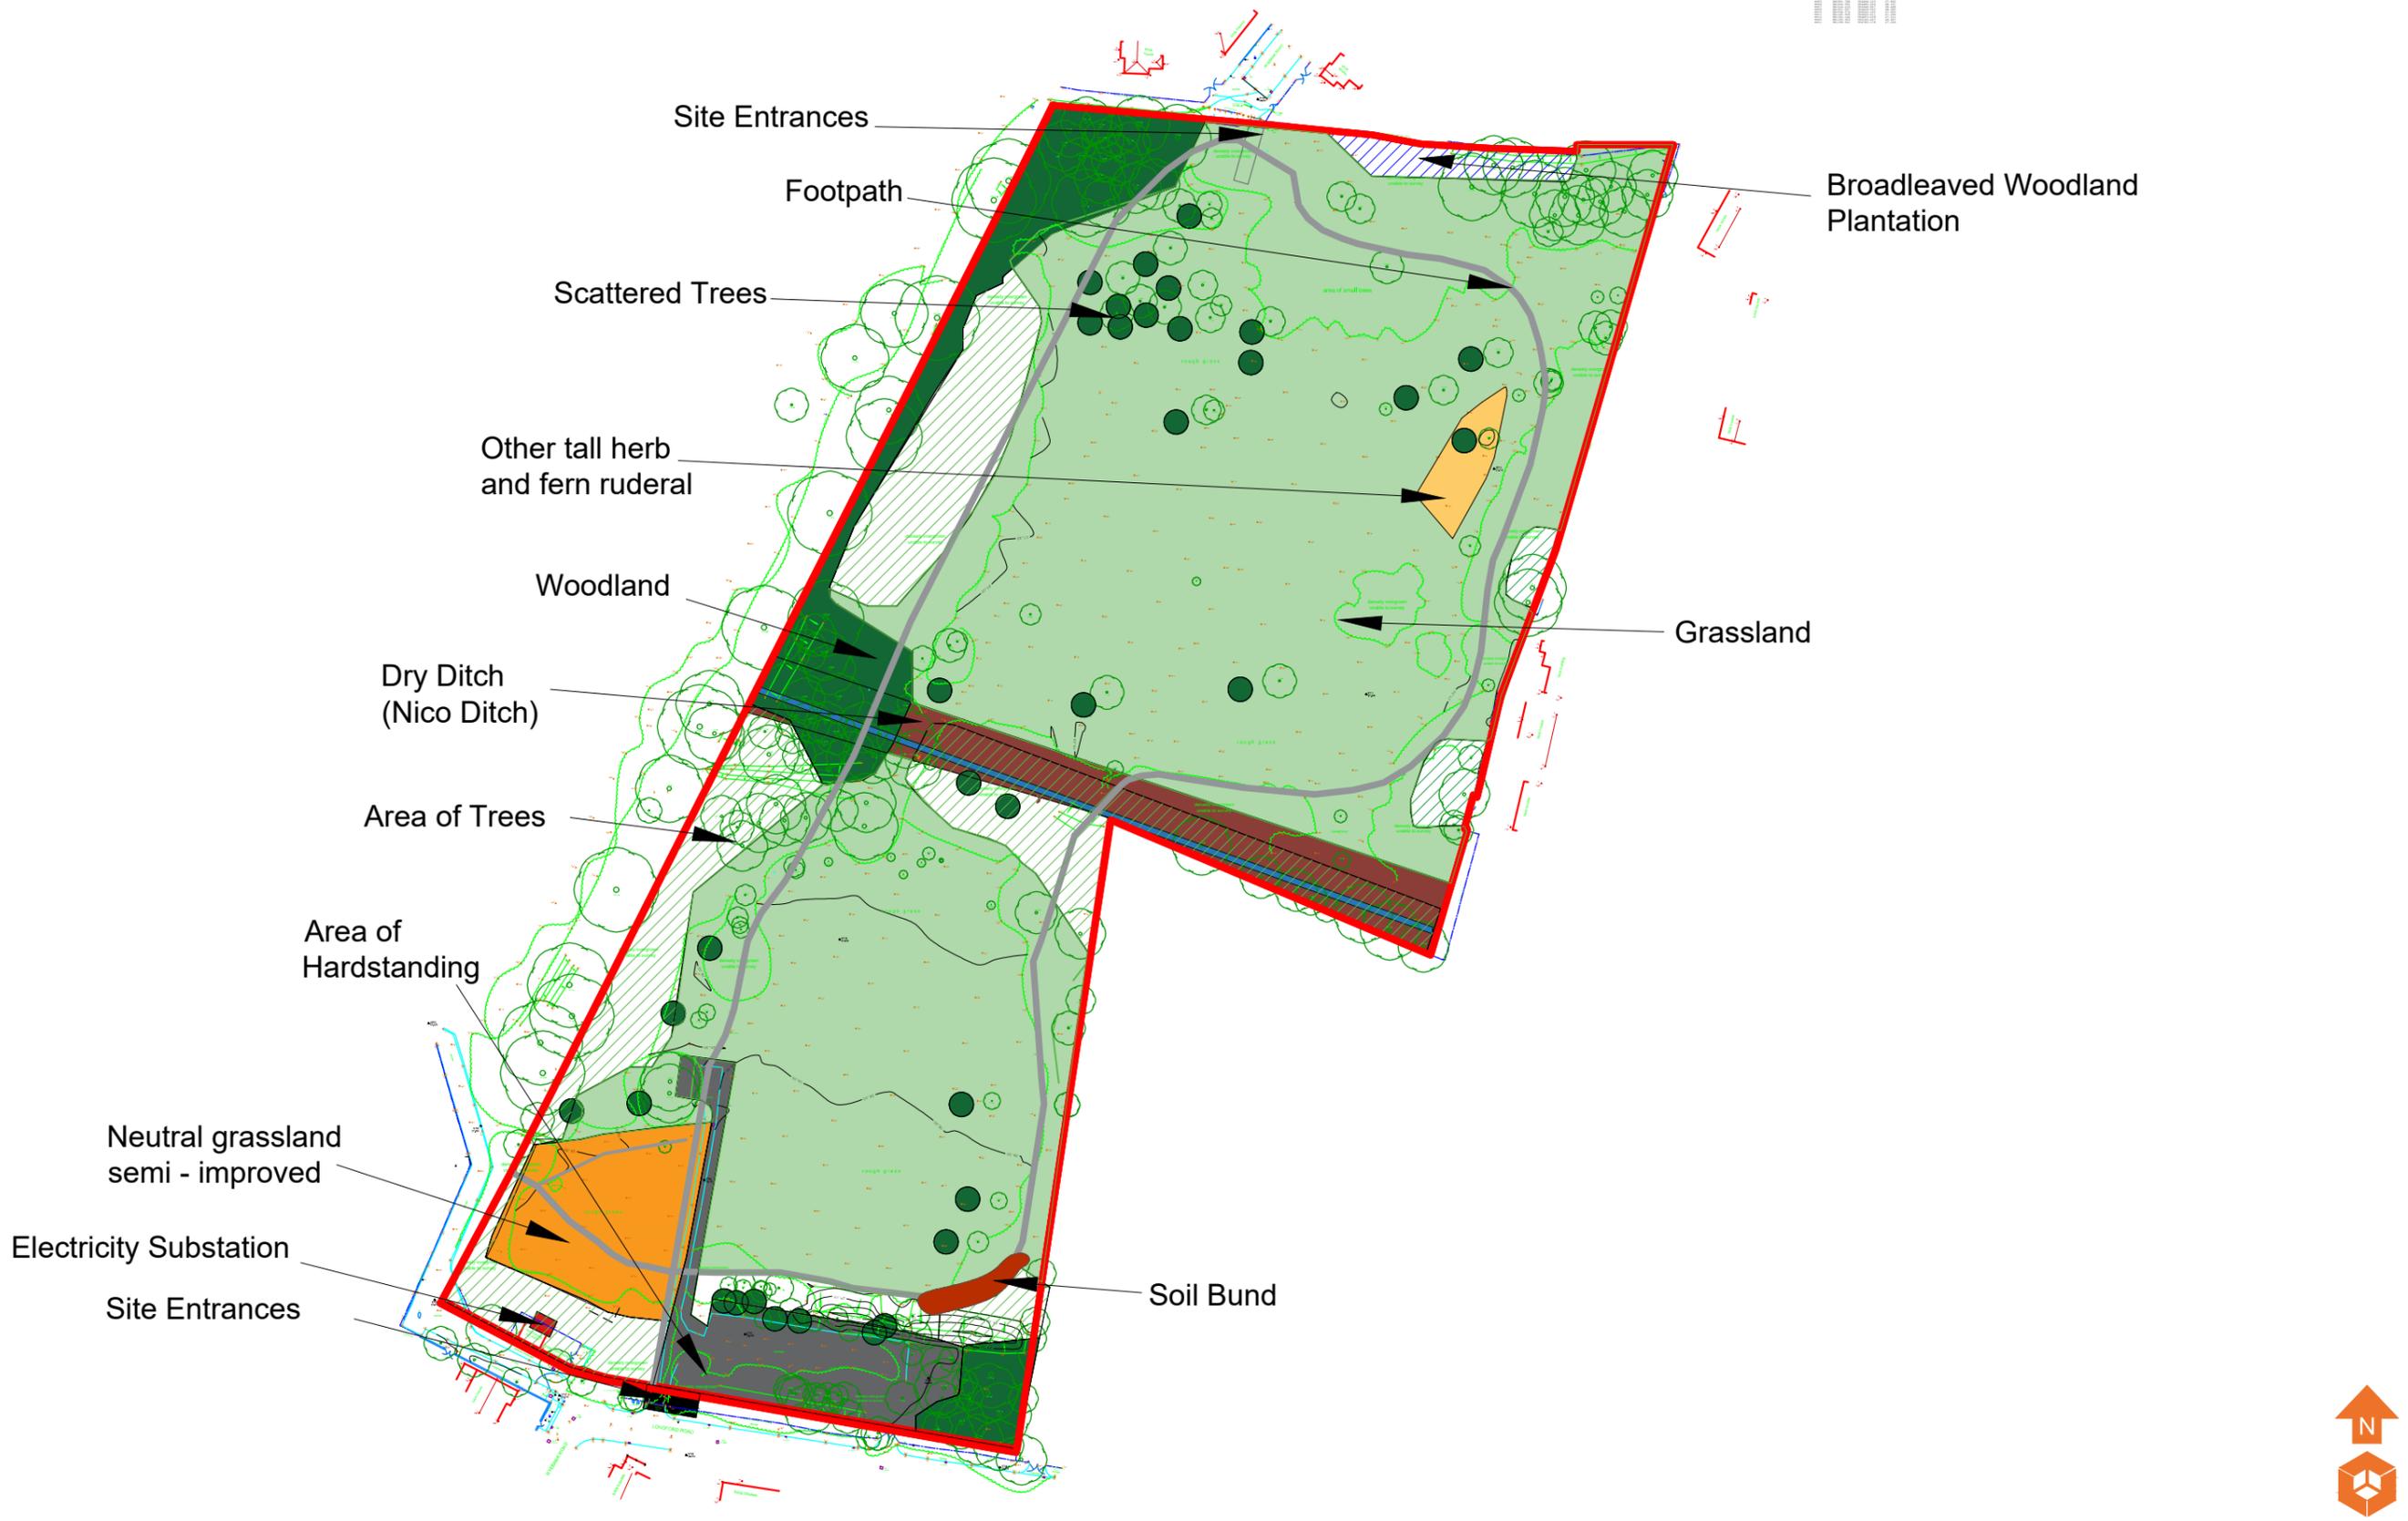
Site Features	
	Hardstanding
	Broadleaved woodland semi-natural
	Dry Ditch
	Footpath
	Sub Station
	Neutral Grassland semi-improved
	Scrub - Dense/Continuous
	Scattered Trees
	Broadleaved Woodland Plantation
	Footpath
	Dry Ditch (Nico)
	Other tall herb and fern ruderal
	Soil Bund
	Grassland
	Site Entrances

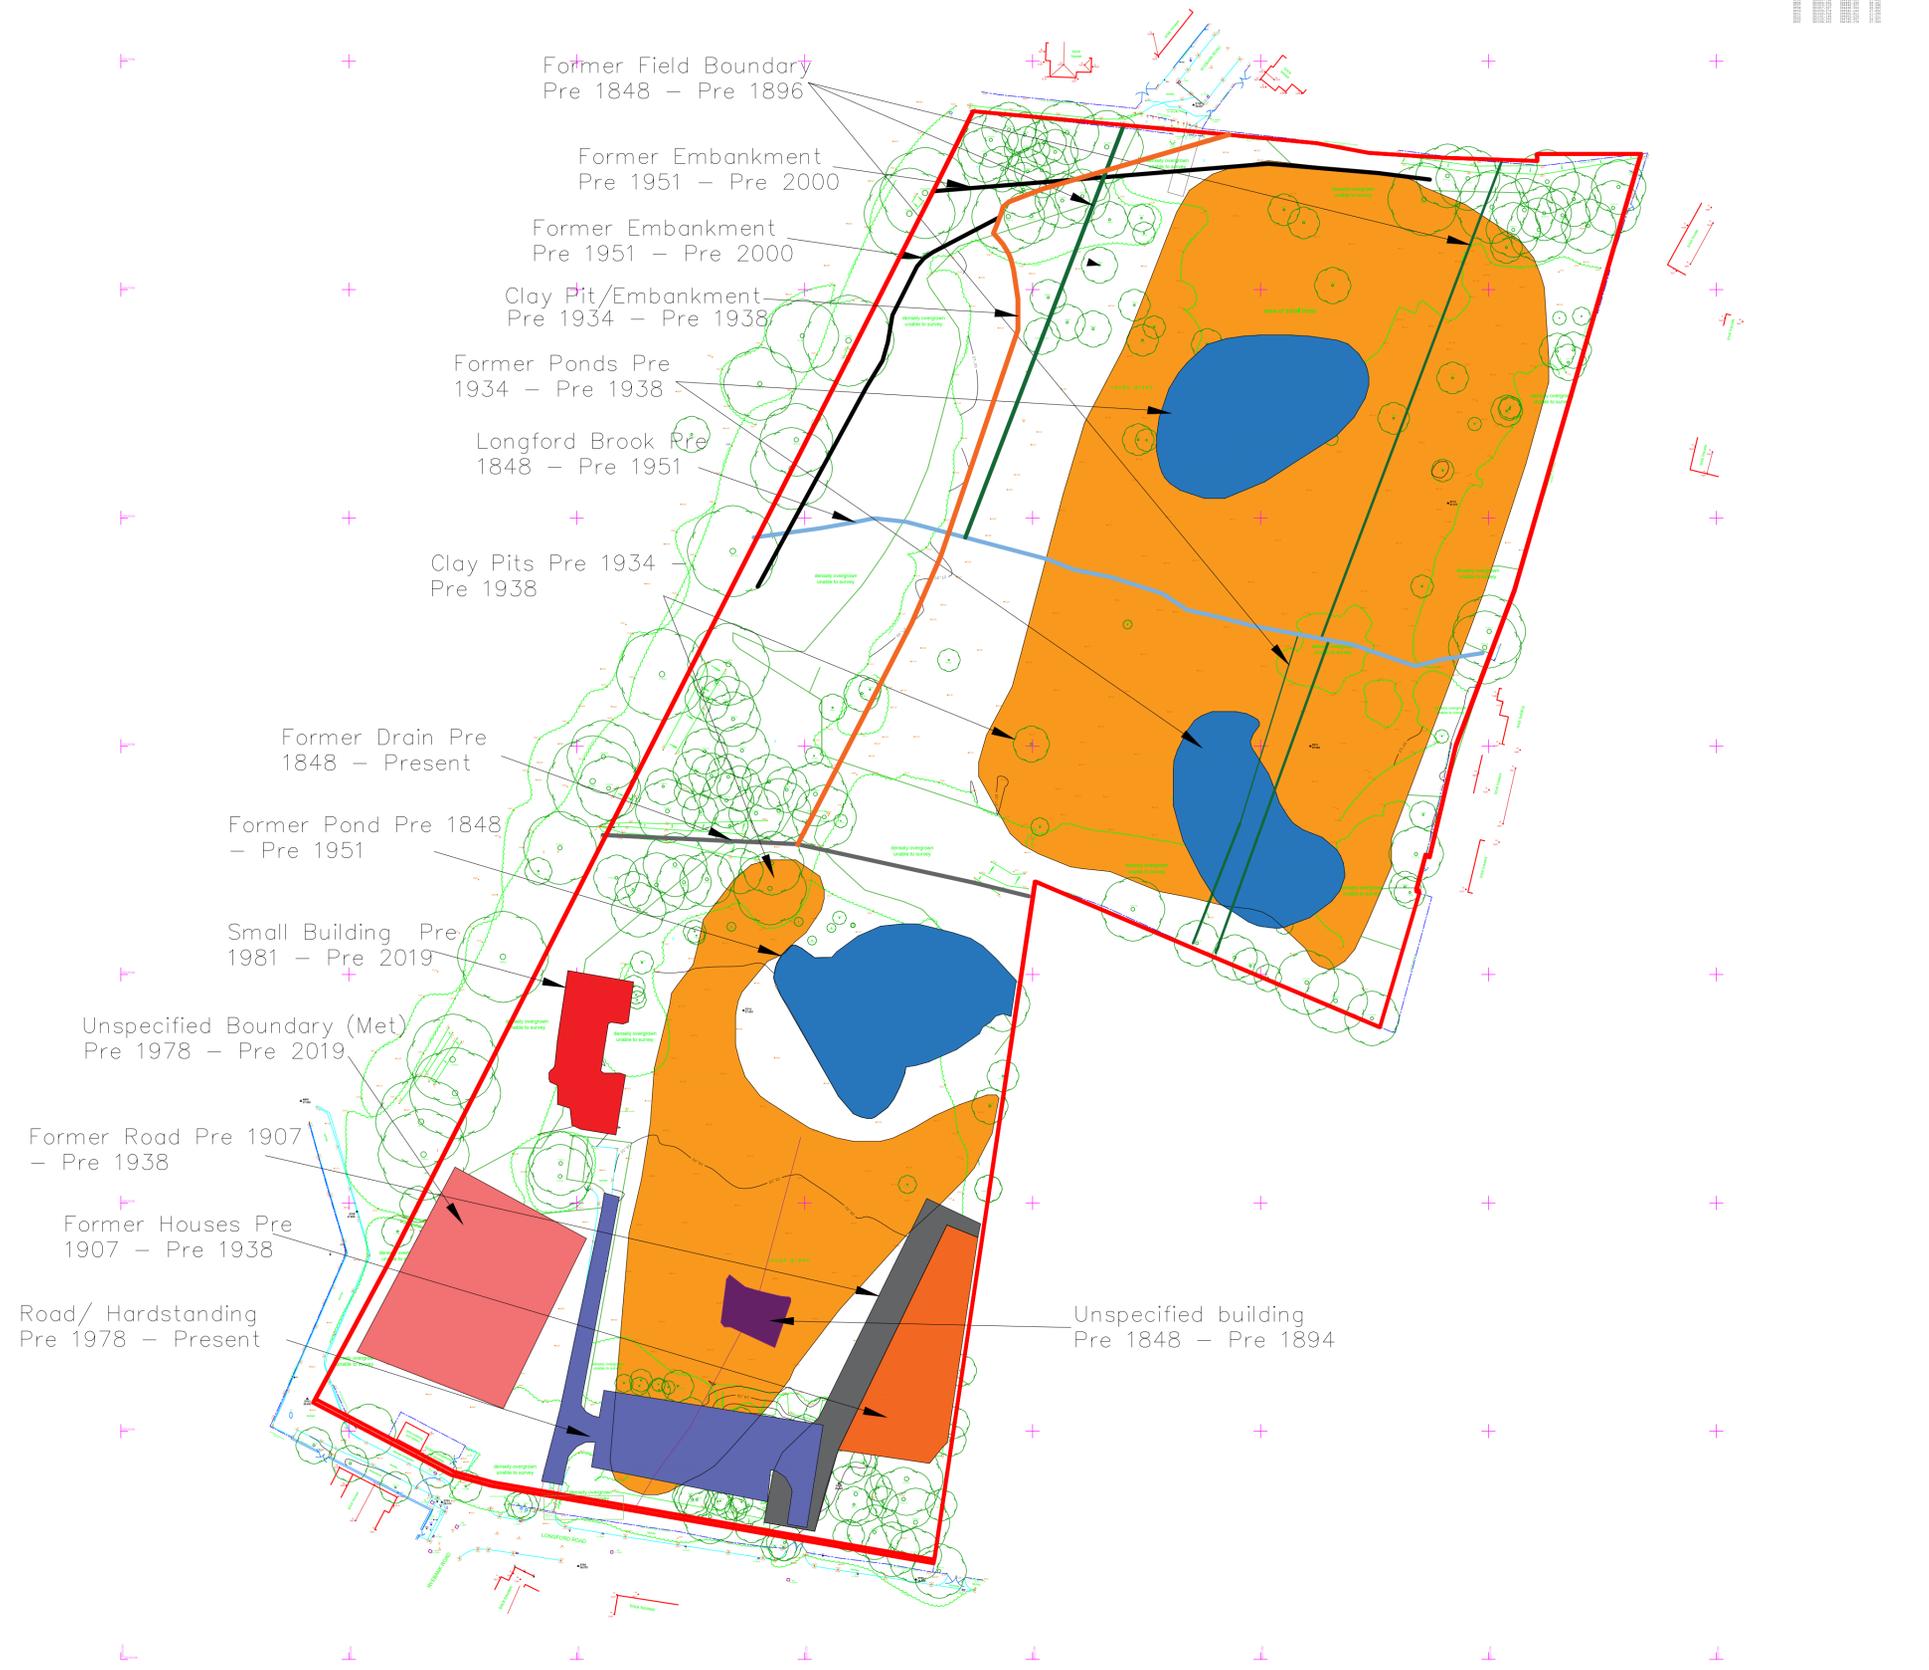
Historical Features

Small Building Pre 1981 - Pre 2019		Former Field Boundary Pre 1848 - Pre 1896
	Former Pond Pre 1848 - Pre 1951 / Pre 1934 - Pre 1938		Former Drain Pre 1848 - Present
	Former Houses Pre 1907 - Pre 1938		Former Embankment Pre 1951 - Pre 2000
	Former Road Pre 1907 - Pre 1938		Former Clay pit/embankment Pre 1934 - Pre 1938
	Unspecified Building Pre - 1848 - Pre 1894		
	Unspecified Boundary (Met) Pre 1978 - Pre 2019		
	Former Clay Pits Pre 1934 - Pre 1938		
	Road/Hardstanding Pre 1978 - Present		
	Longford Brook Pre 1848 - Pre 1951

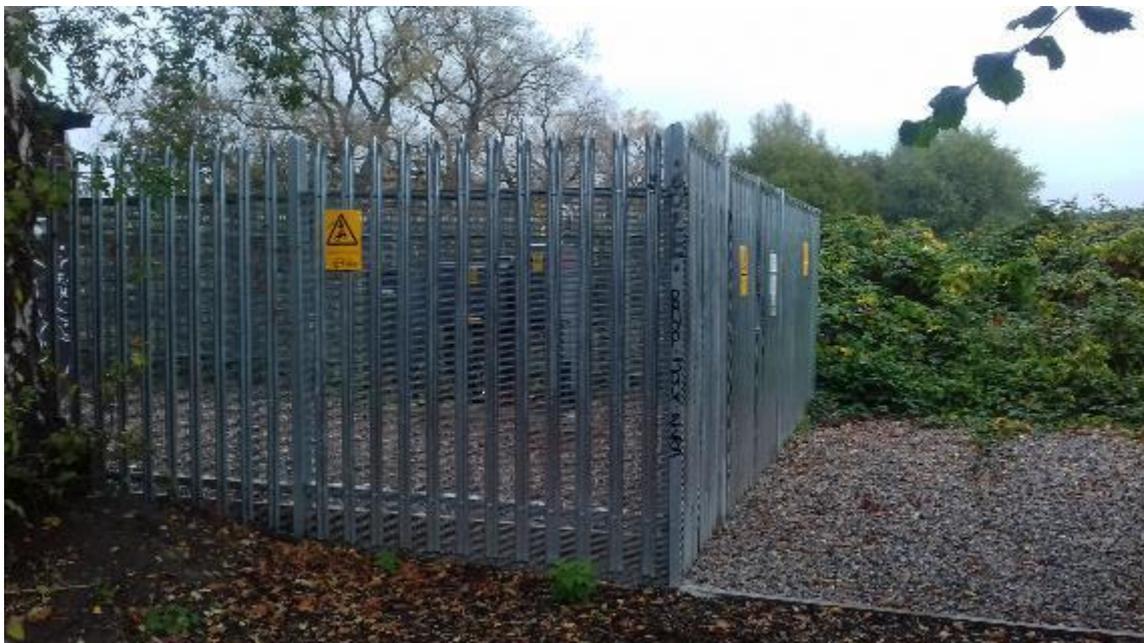
PLATE 1 ELECTRCITY SUBSTATION ADJACENT TO SOUTHERN BOUNDARY

Polychlorinated Biphenyls (PCBs)	There is an electric substation present adjacent to south western boundary of the site, however this is understood to be outside of the red line boundary.	
Waste Storage	Potentially hazardous waste streams are unlikely to be generated at the site and none were observed during the preliminary site inspection.	
Drainage	<p>A full GPR survey has not been completed however a review of online service records have identified an intermediate pressure gas main to dissect the site north to south, with a low pressure gas main present in the south-west of the site.</p> <p>BT and electricity service infrastructure is present in the south-western corner of the site.</p> <p>United Utilities have noted the presence of a surface water sewer in the south of the site with an overflow sewer within the north of the site. Adjacent to the northern boundary is the Thirlmere Aqueduct, an LDTM Treated Water Trunk Main.</p>

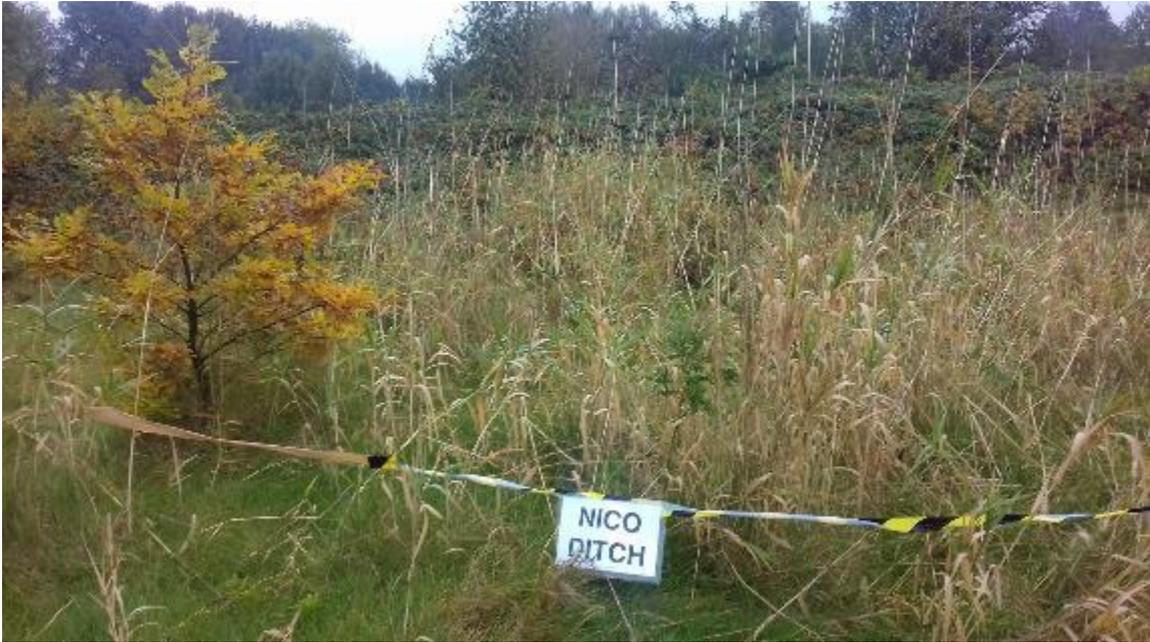
PLATE 9 NICO DITCH

Hydrology	<p>The Nico Ditch (referred to as a drain) is intersecting the centre of the site however it is noted to be dry. A drain is located 156 m west of the site. Moreover, United Utilities have indicated that the route of the Thirlmere Aqueduct runs across the northern boundary of the site. Longford Brook (culverted) is located circa 210 m west of the site. Longford Brook historically flowed through the site, however has since been diverted.</p>

- ✦ The topography of the site is generally flat however a ditch runs through the centre of the site noted to be dry and overgrown with scrub with a crossing over the ditch in the centre of the site.

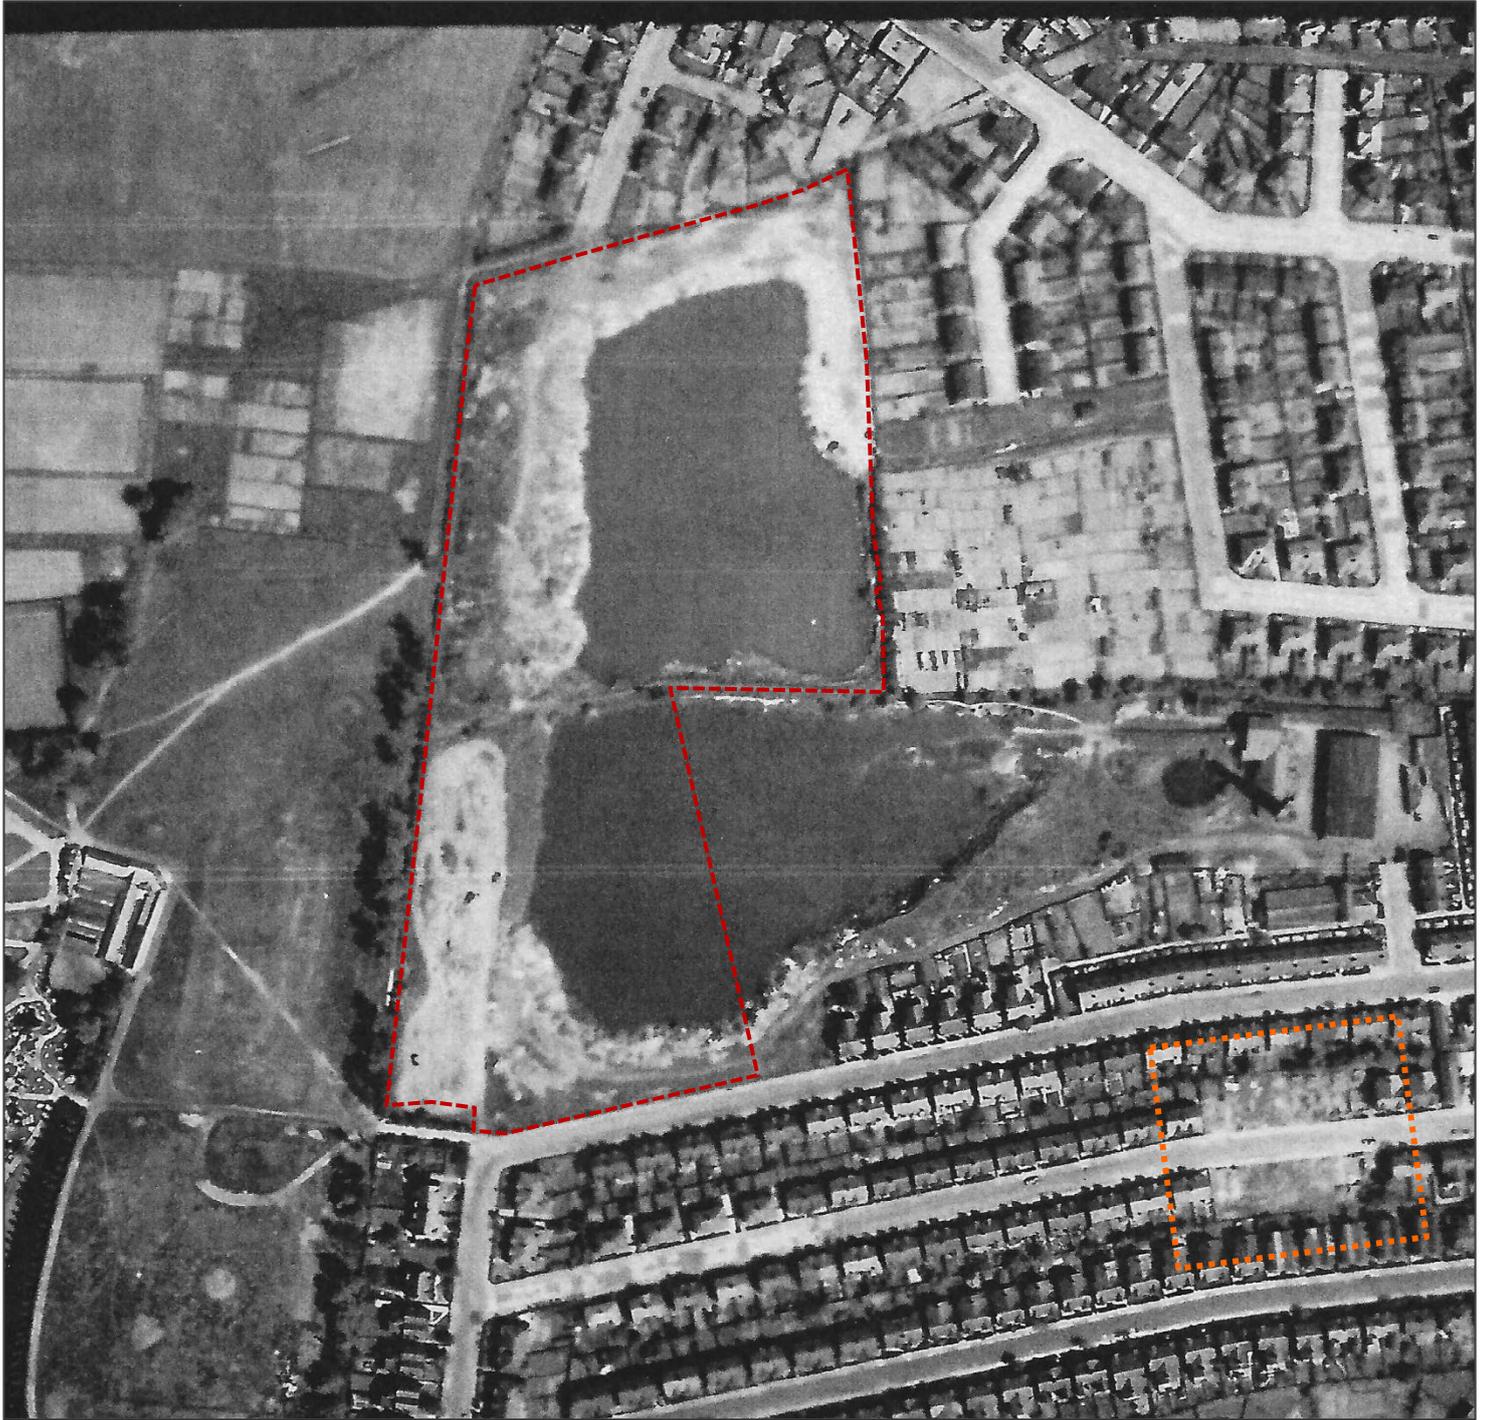
These original WWII-era maps were produced by Manchester City Council's Architect's Department (Building Surveyor's Division) during the war and were updated throughout the conflict to reflect all raids on the county borough. No original legend / key accompanies the maps, however a contemporary description does confirm most of the symbols. No symbol for UXBs was identified. Any IB strike symbol with a number written within it represents the number of individual IBs falling at that location. Sections of the maps covering the study area have been combined and are displayed at **FIGURE 5**.

..... Bomb damage

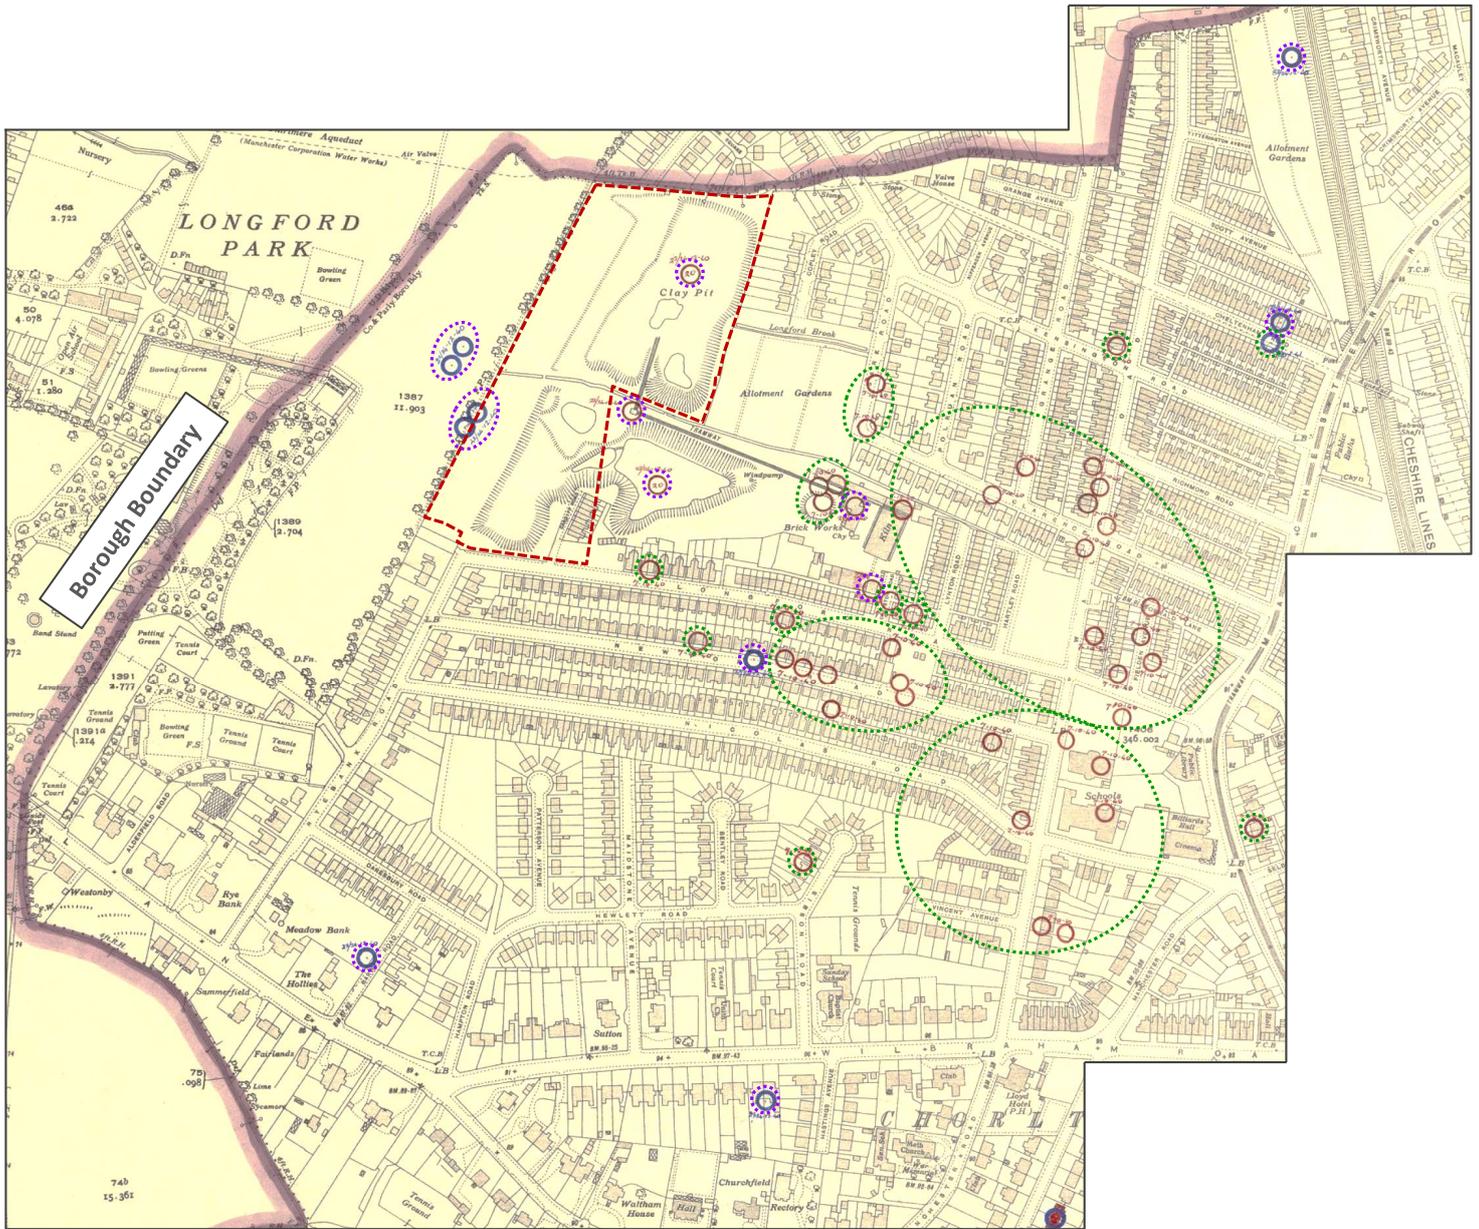
Note: each bomb strike's date of fall has been identified by coloured circles;
 07/10/40
 22/12/40

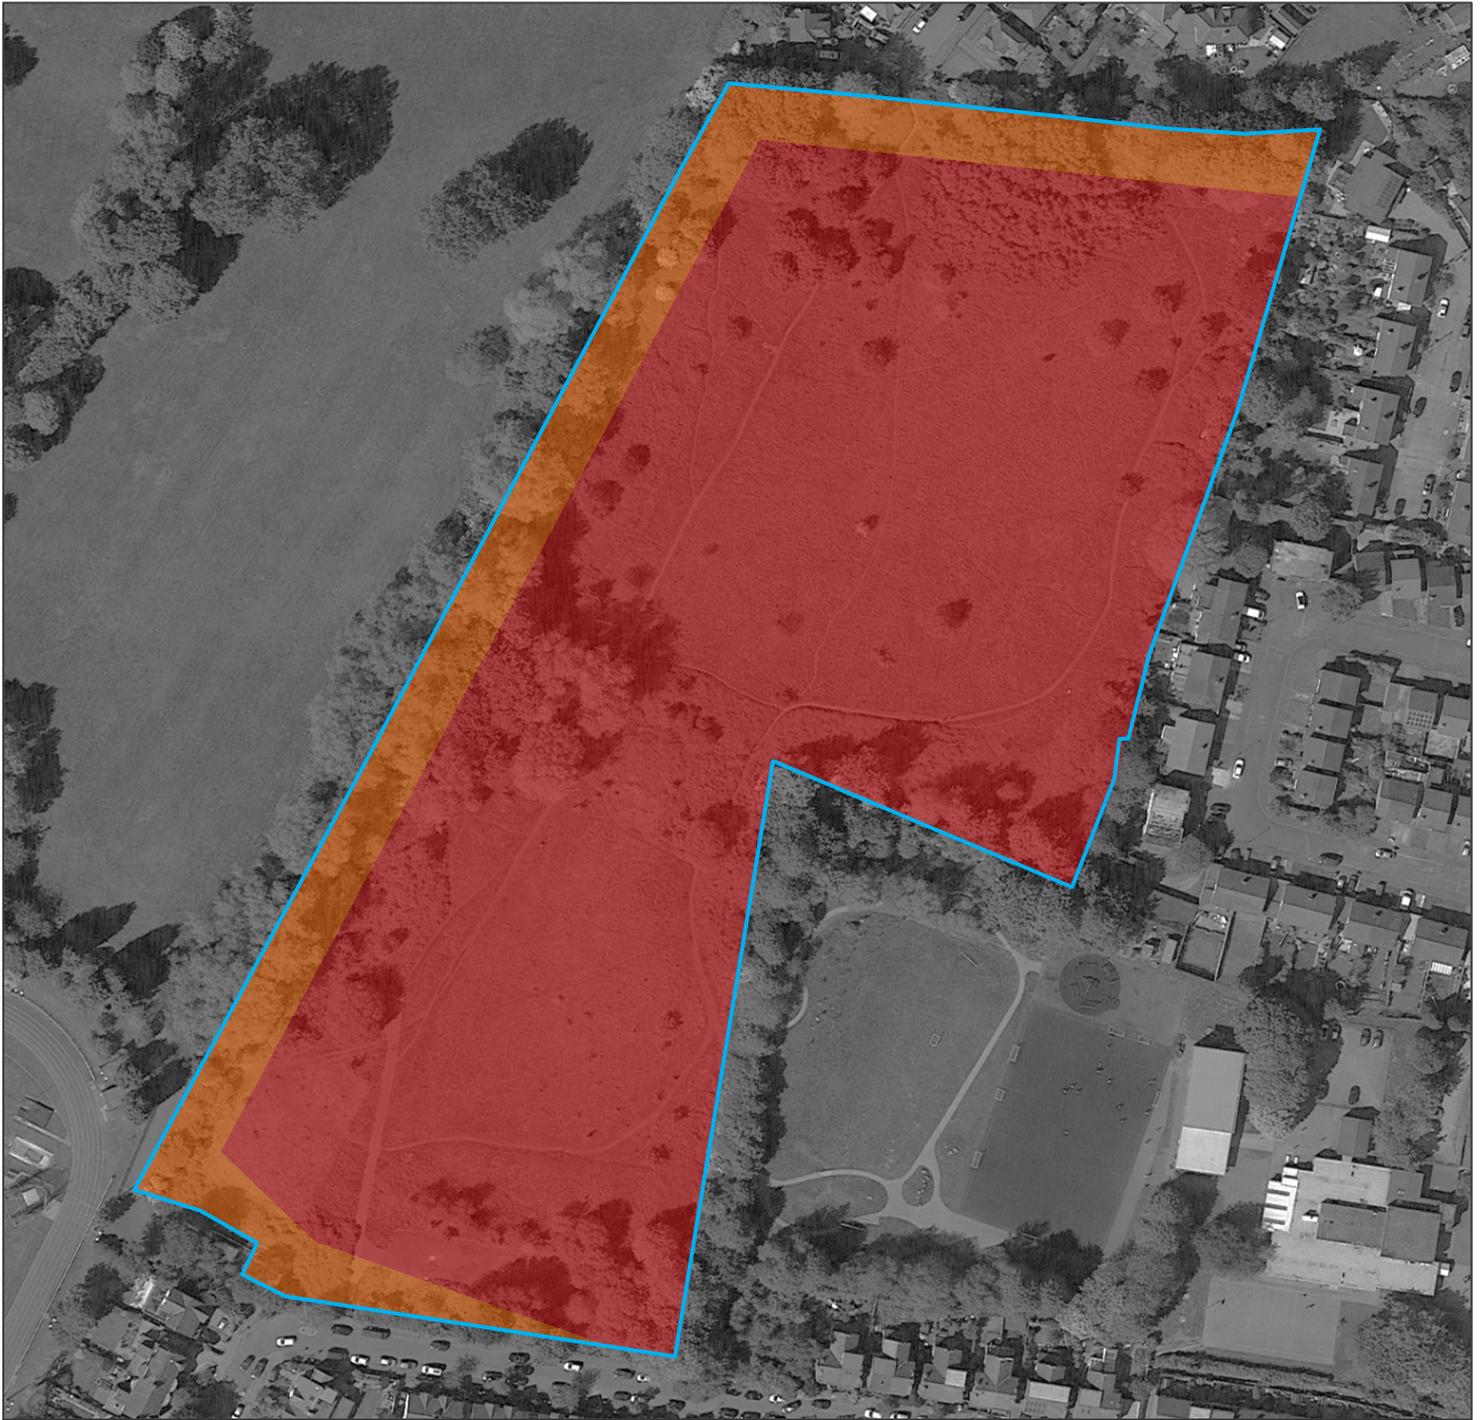
Ratings for the likelihood of UXO contaminating *The Site*, remaining on *Site* up to the present day and being encountered during the proposed works, inform the overall risk rating. The UXO risk to the proposed works on *Site* has been assessed as **Moderate** and **High**. A Risk Map (likelihood of UXO remaining on *Site*) is displayed at **FIGURE 6**.

MODERATE RISK ZONE

Elevated likelihood of German and British UXO remaining here.

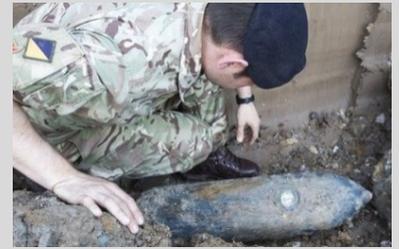
SC 50

Bomb Weight: 40-54kg (110-119lb)
Explosive Weight: 25kg (55lb)
Filling: TNT, Amatol or Trialen
Charge/Weight Ratio: 46%
Fuse Type: Electrical impact fuse or mechanical delayed action fuse
Body Dimensions: 1,100mm length x 200mm diameter
Appearance: Bomb body and tail painted grey/green with a yellow stripe on the tail unit. Steel construction.
Variants: 8 x variants. Additional fittings: Kopfring nose for limited penetration and Stabbo nose for dive-bombing.

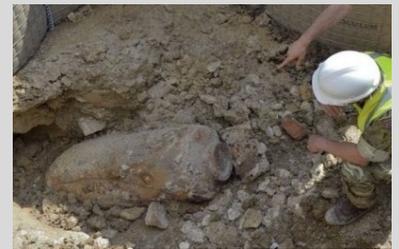
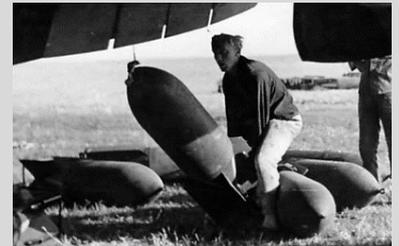
SC 250

Bomb Weight: 245-256kg (540-564lb)
Explosive Weight: 125-130kg (276-287lb)
Filling: TNT, Amatol and Trialen mix
Charge/Weight Ratio: 44%
Fuse Type: 1 or 2 electrical impact fuse(s) or mechanical delayed action fuse(s)
Body Dimensions: 1,173mm length x 368mm diameter
Appearance: Bomb body and tail painted grey/green with a yellow stripe on the tail unit. Steel construction.
Variants: 8 x variants. Kopfring nose for limited penetration. Stabbo nose for dive-bombing.

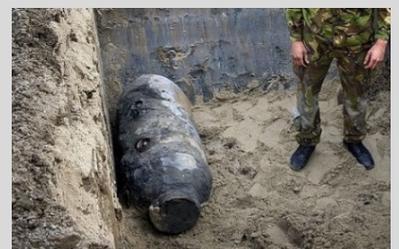
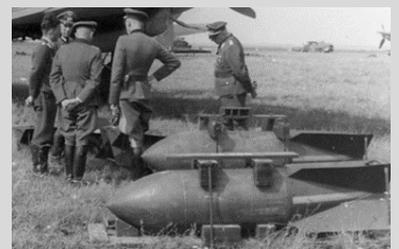
SC 500

Bomb Weight: 480-520kg (1,058-1,146lb)
Explosive Weight: 220kg (485lb)
Filling: TNT, Amatol and Trialen mix
Charge/Weight Ratio: 44%
Fuse Type: 2 electrical impact fuses or mechanical delayed action fuses
Body Dimensions: 1,423mm length x 470mm diameter
Appearance: Bomb body and tail painted grey/green or buff with a yellow stripe on the tail unit. Steel construction.
Variants: 3 x variants. Kopfring nose for limited penetration.

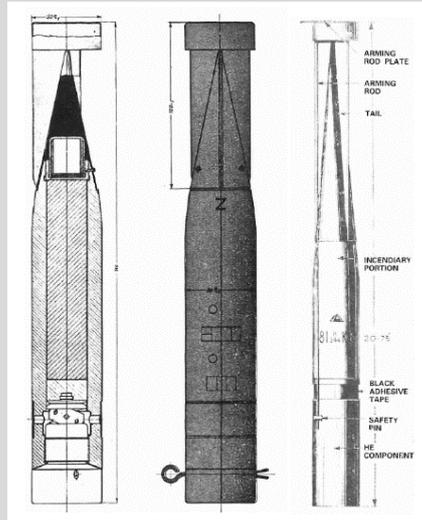
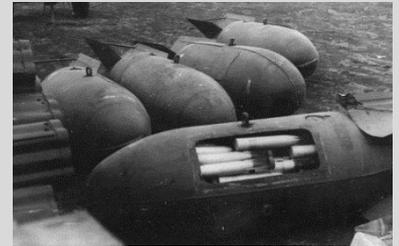
Bomb Weight: 1-1.3kg (2.2-2.87lb)
Incendiary Weight: 680g (1.4lb)
Filling: Thermite
Fuse Type: Simple impact fuse
Body Dimensions: 247mm length x 50mm diameter
Appearance: Grey body and dark green painted tail unit. Magnesium alloy case.
Operation: Small percussion charge ignites Thermite (>1,000°C burn).
Variants: Most common variant: B 2EZ (2kg) included a small HE charge
Remarks: Drop containers varied in size. The smallest cluster bomb held 36 x B-1Es and the largest 620 x B-1Es.

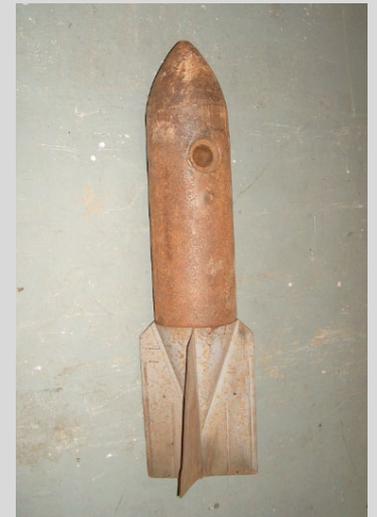
Brand C50

Bomb Weight: 41kg (90.4lb)
Incendiary Weight: 13kg (30lb)
Filling: Main fill (86% Benzine, 10% Rubber) plus 4% Phosphorus in glass bottles
Fuse Type: 1 x electrical impact fuse
Bomb Dimensions: 762mm length x 203mm diameter
Appearance: bomb body and tail painted grey or green with the rear of the bomb painted red and a red band around the centre of the body.
Variants: C 50 B: 77% White Phos fill
 C 250 A: 87.7% Petroleum, 11.7% Polystyrene, 0.5% White Phos (185kg version)

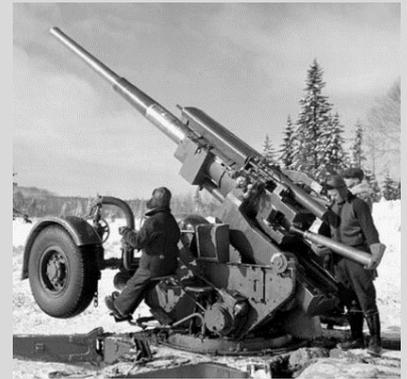
HAA Battery - 3.7" QF Shell

Shell Weight: 12.7kg
Shell Dimensions: 94mm x 438mm
Fill Weight: 1.1kg
Fill Type: TNT
Fuse Type: Mechanical Time Delay fuse
Appearance: Grey body, copper driving bands, brass neck
Rate of Fire: 10 - 20 rpm
Ceiling: 9,000 - 18,000m
Variants: HE or shrapnel shells.
 Note, the 4.5" gun was also used in an HAA role throughout the UK.

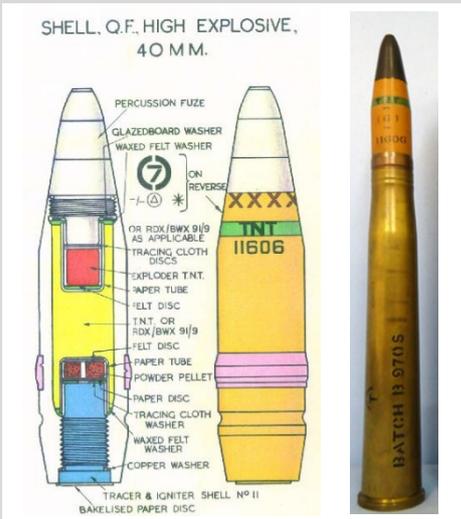
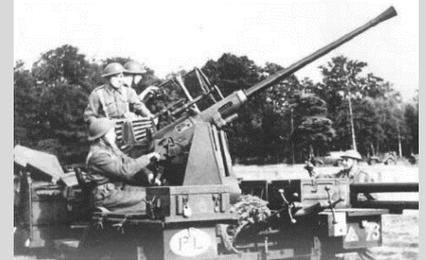
LAA Battery - 40mm Bofors Shell

Shell Weight: 0.84kg
Shell Dimensions: 40mm x 180mm
Fill Weight: 70g
Fill Type: TNT
Fuse Type: Impact fuse
Appearance: Grey body, copper driving bands, brass neck
Rate of Fire: 120 rpm
Ceiling: 7,000m
Variants: HE or AP shells. Both with rear tracer compartment

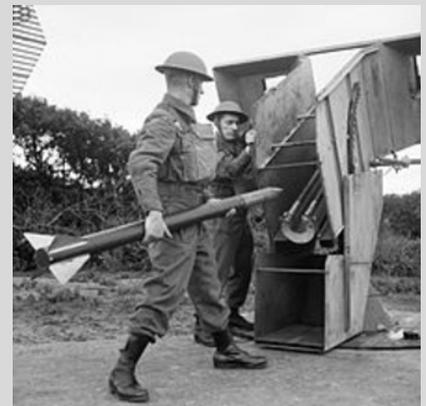
Z Battery - 3" U.P Rocket

Rocket Weight: 24.5kg
Warhead Weight: 1.94kg
Filling: TNT warhead. Black Powder solid fuel rocket motor.
Fuse Type: Mechanical Time Delay fuse
Rocket Dimensions: 1,930mm x 76mm
Ceiling: 6,770m
Operation: Fired from single, tandem and (later) 36 x rail launchers (Z Batteries). Limited use throughout the UK.

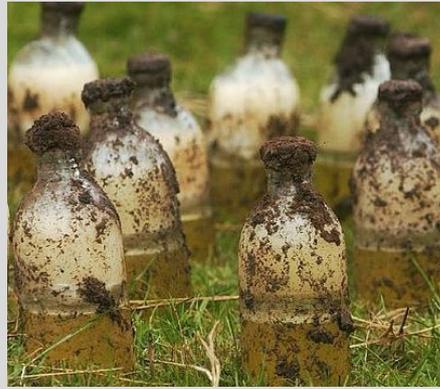
No. 76 Self Igniting Grenade (SIP)

Construction: Glass bottle and metal stopper
Weight: 0.59kg
Dimensions: 152mm x 63mm
Hazardous Fill: White Phosphorus and Benzene
Fuse: n/a
Appearance: White / off yellow milk bottle
Hazards: Choking fumes of Phosphorus Pentoxide and Sulphur Dioxide, as well as heat. Severe burns if comes into contact with skin.
Remarks: By August 1941 well over 6,000,000 of these grenades were available and mainly issued to the Home Guard.

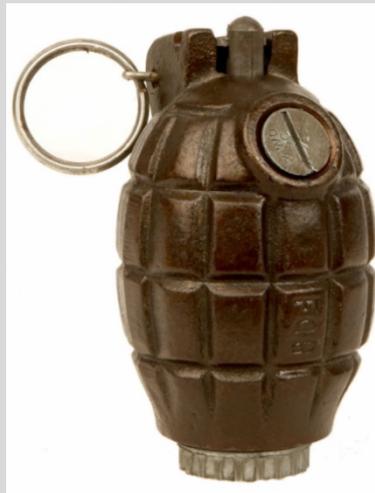
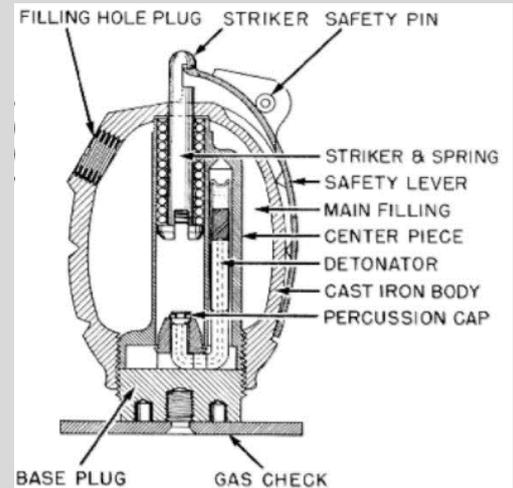
No. 36 Hand Grenade (Mills Bomb)

Construction: Metal
Dimensions: 95mm x 61mm
Weight: 760g
Fill weight: 71g
Hazardous Fill: Baratol
Fuse: Percussion cap and 4 second time delay fuse
Hazards: Blast, fragmentation. ~30m effective range.
Remarks: >70 million were produced between 1915 and the 1980s

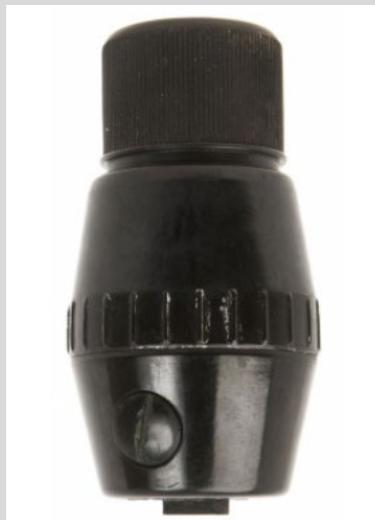
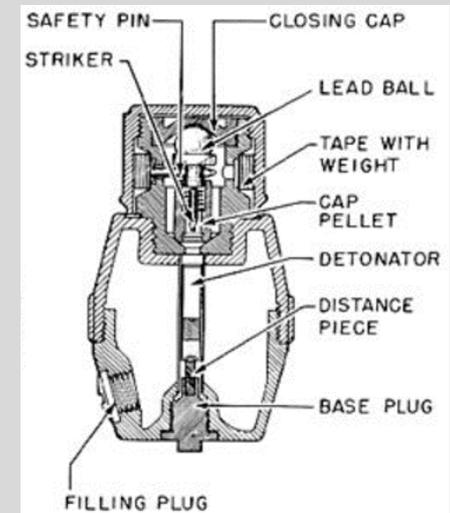
No. 69 (Blast) Hand Grenade

Construction: Bakelite (plastic)
Dimensions: 114mm x 60mm
Weight: 383g
Fill weight: 92g
Hazardous Fill: Baratol, Amatol or Lyddite
Fuse: 'All-Ways' Impact fuse
Hazards: Blast effect. <20m effective range.
Remarks: Green bands around the grenade signified a HE fill.

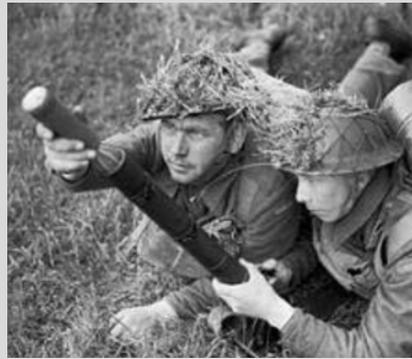
2" ML Mortar - High Explosive

Weight: 1.02kg
Dimensions: 51mm x 290mm
Hazardous Fill: 200g of RDX/TNT
Fuse: Impact fuse
Appearance: Cylindrical shape. Brown body, green and red bands, five finned tail
Variants: Several smoke, inert practice and parachute illumination versions were manufactured
Remarks: Common anti-personnel weapon in use with British Army throughout WWII. >12.5 million HE rounds were produced in 1942 alone

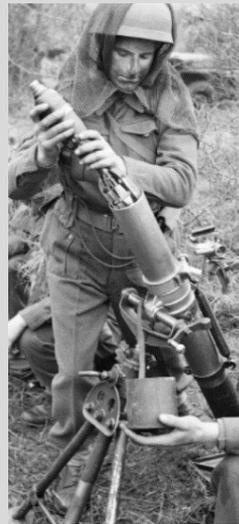
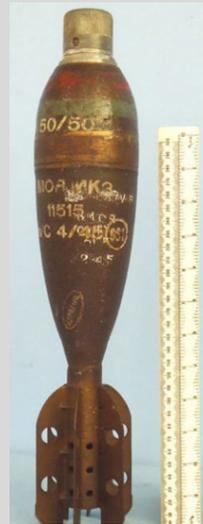
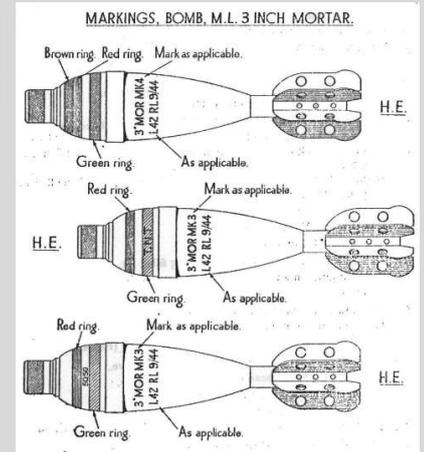
3" ML Mortar - High Explosive

Weight: 4.5kg
Dimensions: 81mm x 490mm
Hazardous Fill: 882g of RDX/TNT
Fuse: Impact fuse
Appearance: Pear-drop shape. Brown body, green and red bands, five finned tail
Variants: Several smoke, white Phosphorus, inert practice and parachute illumination versions were manufactured
Remarks: Common anti-personnel weapon in use with British Army throughout WWII. >6.5 million HE rounds were produced in 1942 alone
