Phase I Geoenvironmental Site Assessment
Ryebank Road
Manchester,
Chorlton
Reference:13-533-R1-2
Date: March 2020

PHASE I GEOENVIRONMENTAL SITE ASSESSMENT

Ryebank Road,
Manchester,
Chorlton
M21 9LU

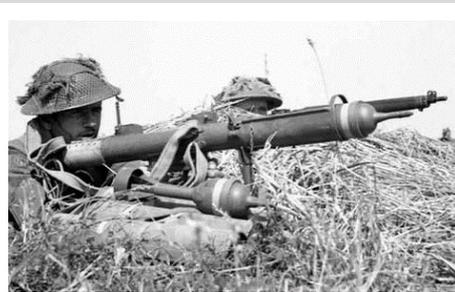
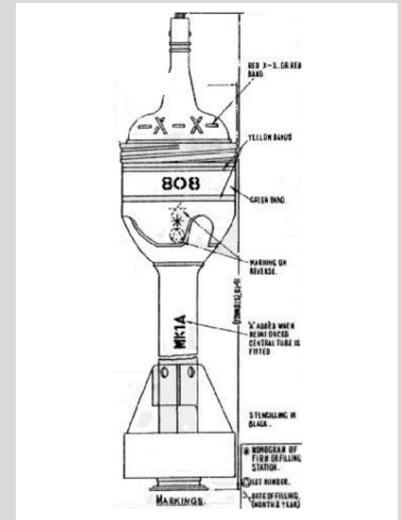
PIAT Anti-Tank Weapon

Projectile Type: HEAT - shaped charge
Projectile Dimensions: 400mm x 90mm
Hazardous Fill: Hollow HE charge and small solid propellant charge
Fill Weight: 1.13kg (charge)
Fuse: Impact fuse
Remarks: 115,000 launchers were produced in Britain during WWII and the PIAT was used by most Allied armies during this conflict

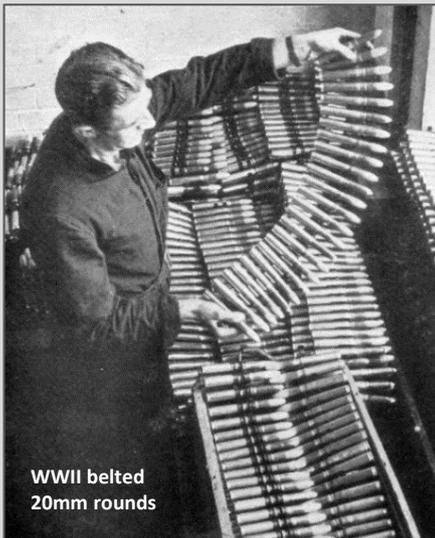
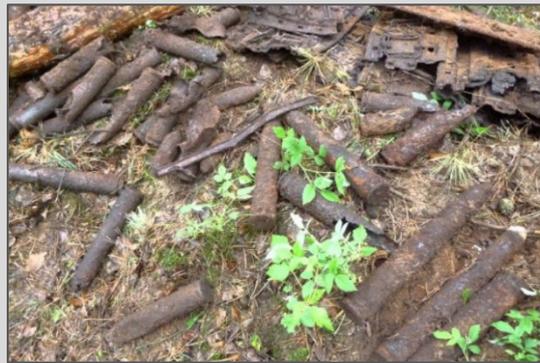
Cartridge Weight: 256g (approx.)
Total Cartridge length: 182mm (approx.)
Hazardous Fill: Various HE, incendiary and tracer compositions. Typically TNT, Tetryl and Pentolite.
Fuse: Impact fuse
Appearance: Cylindrical shape. Brown body, green and red bands, five finned tail
Variants: Oerlikon and Hispano 20mm ammunition was deployed in the UK during WWII. These varied slightly in shape and also in the colours used to identify different projectile types.
Remarks: Today, 20mm rounds of WWII vintage may be found unexpended as full single cartridges or in belts of multiple cartridges. Or expended, i.e just the fused projectile without the brass base.

Bottom Right: Colour identification of Hispano rounds

Bottom Left: Colour identification of Oerlikon rounds
