Phase II Geoenvironmental Site Assessment Rye Bank Fields

PHASE II GEOENVIRONMENTAL SITE ASSESSMENT

Rye Bank Fields Ryebank Road, Manchester, Chorlton M21 9LU

Report Ref: 13-533-R2-2 Date Issued: 30/03/2020

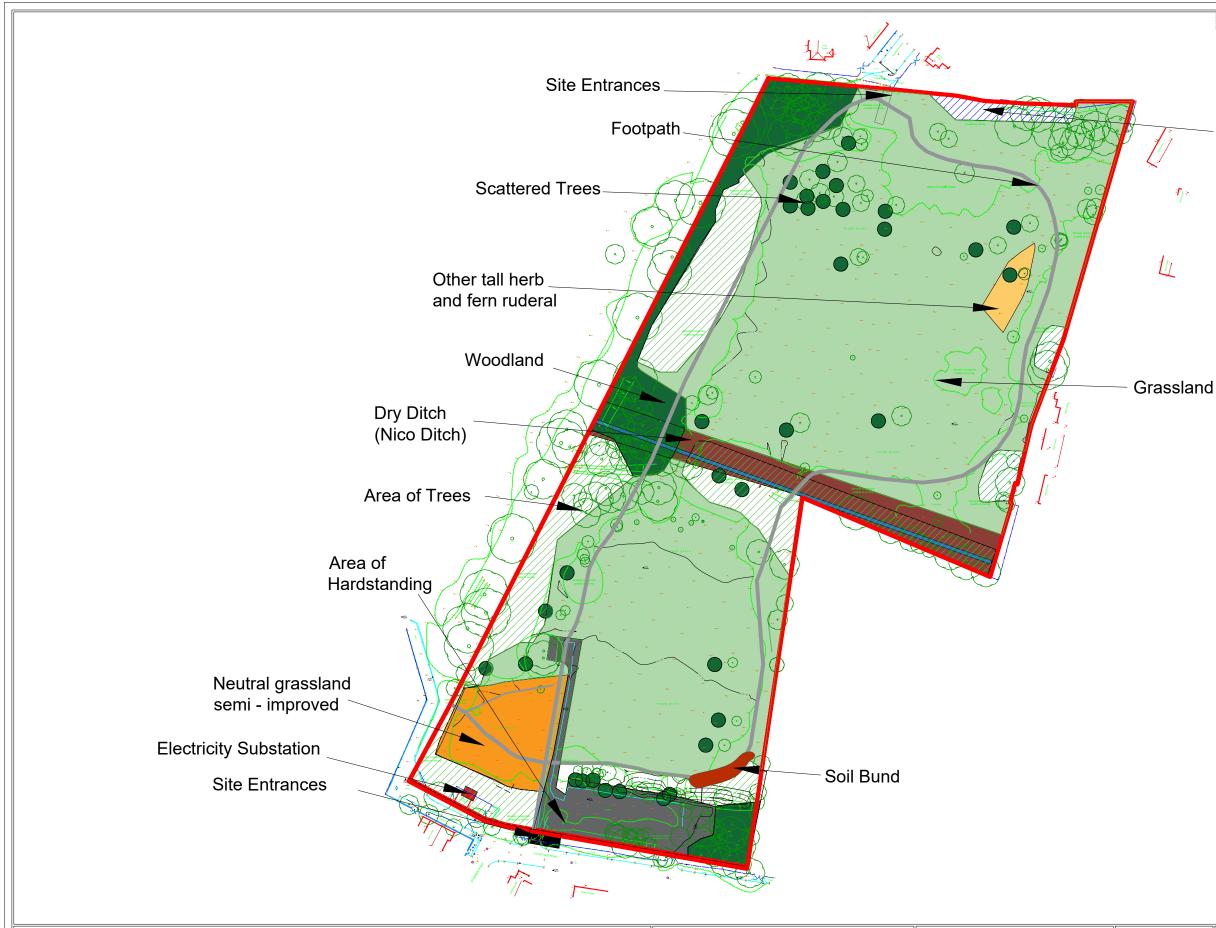
Site Features	Notes:	Notes:					Client:	Job No:
Hardstanding Dry Ditch (Nico) Broadleaved woodland semi-natural Other tall herb and fern ruderal							Manchester	13-533
Dry Ditch Soil Bund							Metropolitan University	Drawing No:
Footpath Grassland								002
Sub Station Site Entrances			1	1		1		
Neutral Grassland semi-improved							Job Title:	Drawing Title:
Scrub - Dense/Continuous							Dvo Book Bood	Cita
Scattered Trees							Rye Bank Road, Chorlton	Site
Broadleaved Woodland Plantation	P1 P1	R1		REVISION DRAFT		BH BH	Chonton	
Footpath	Phase	Revision	Date			Checked

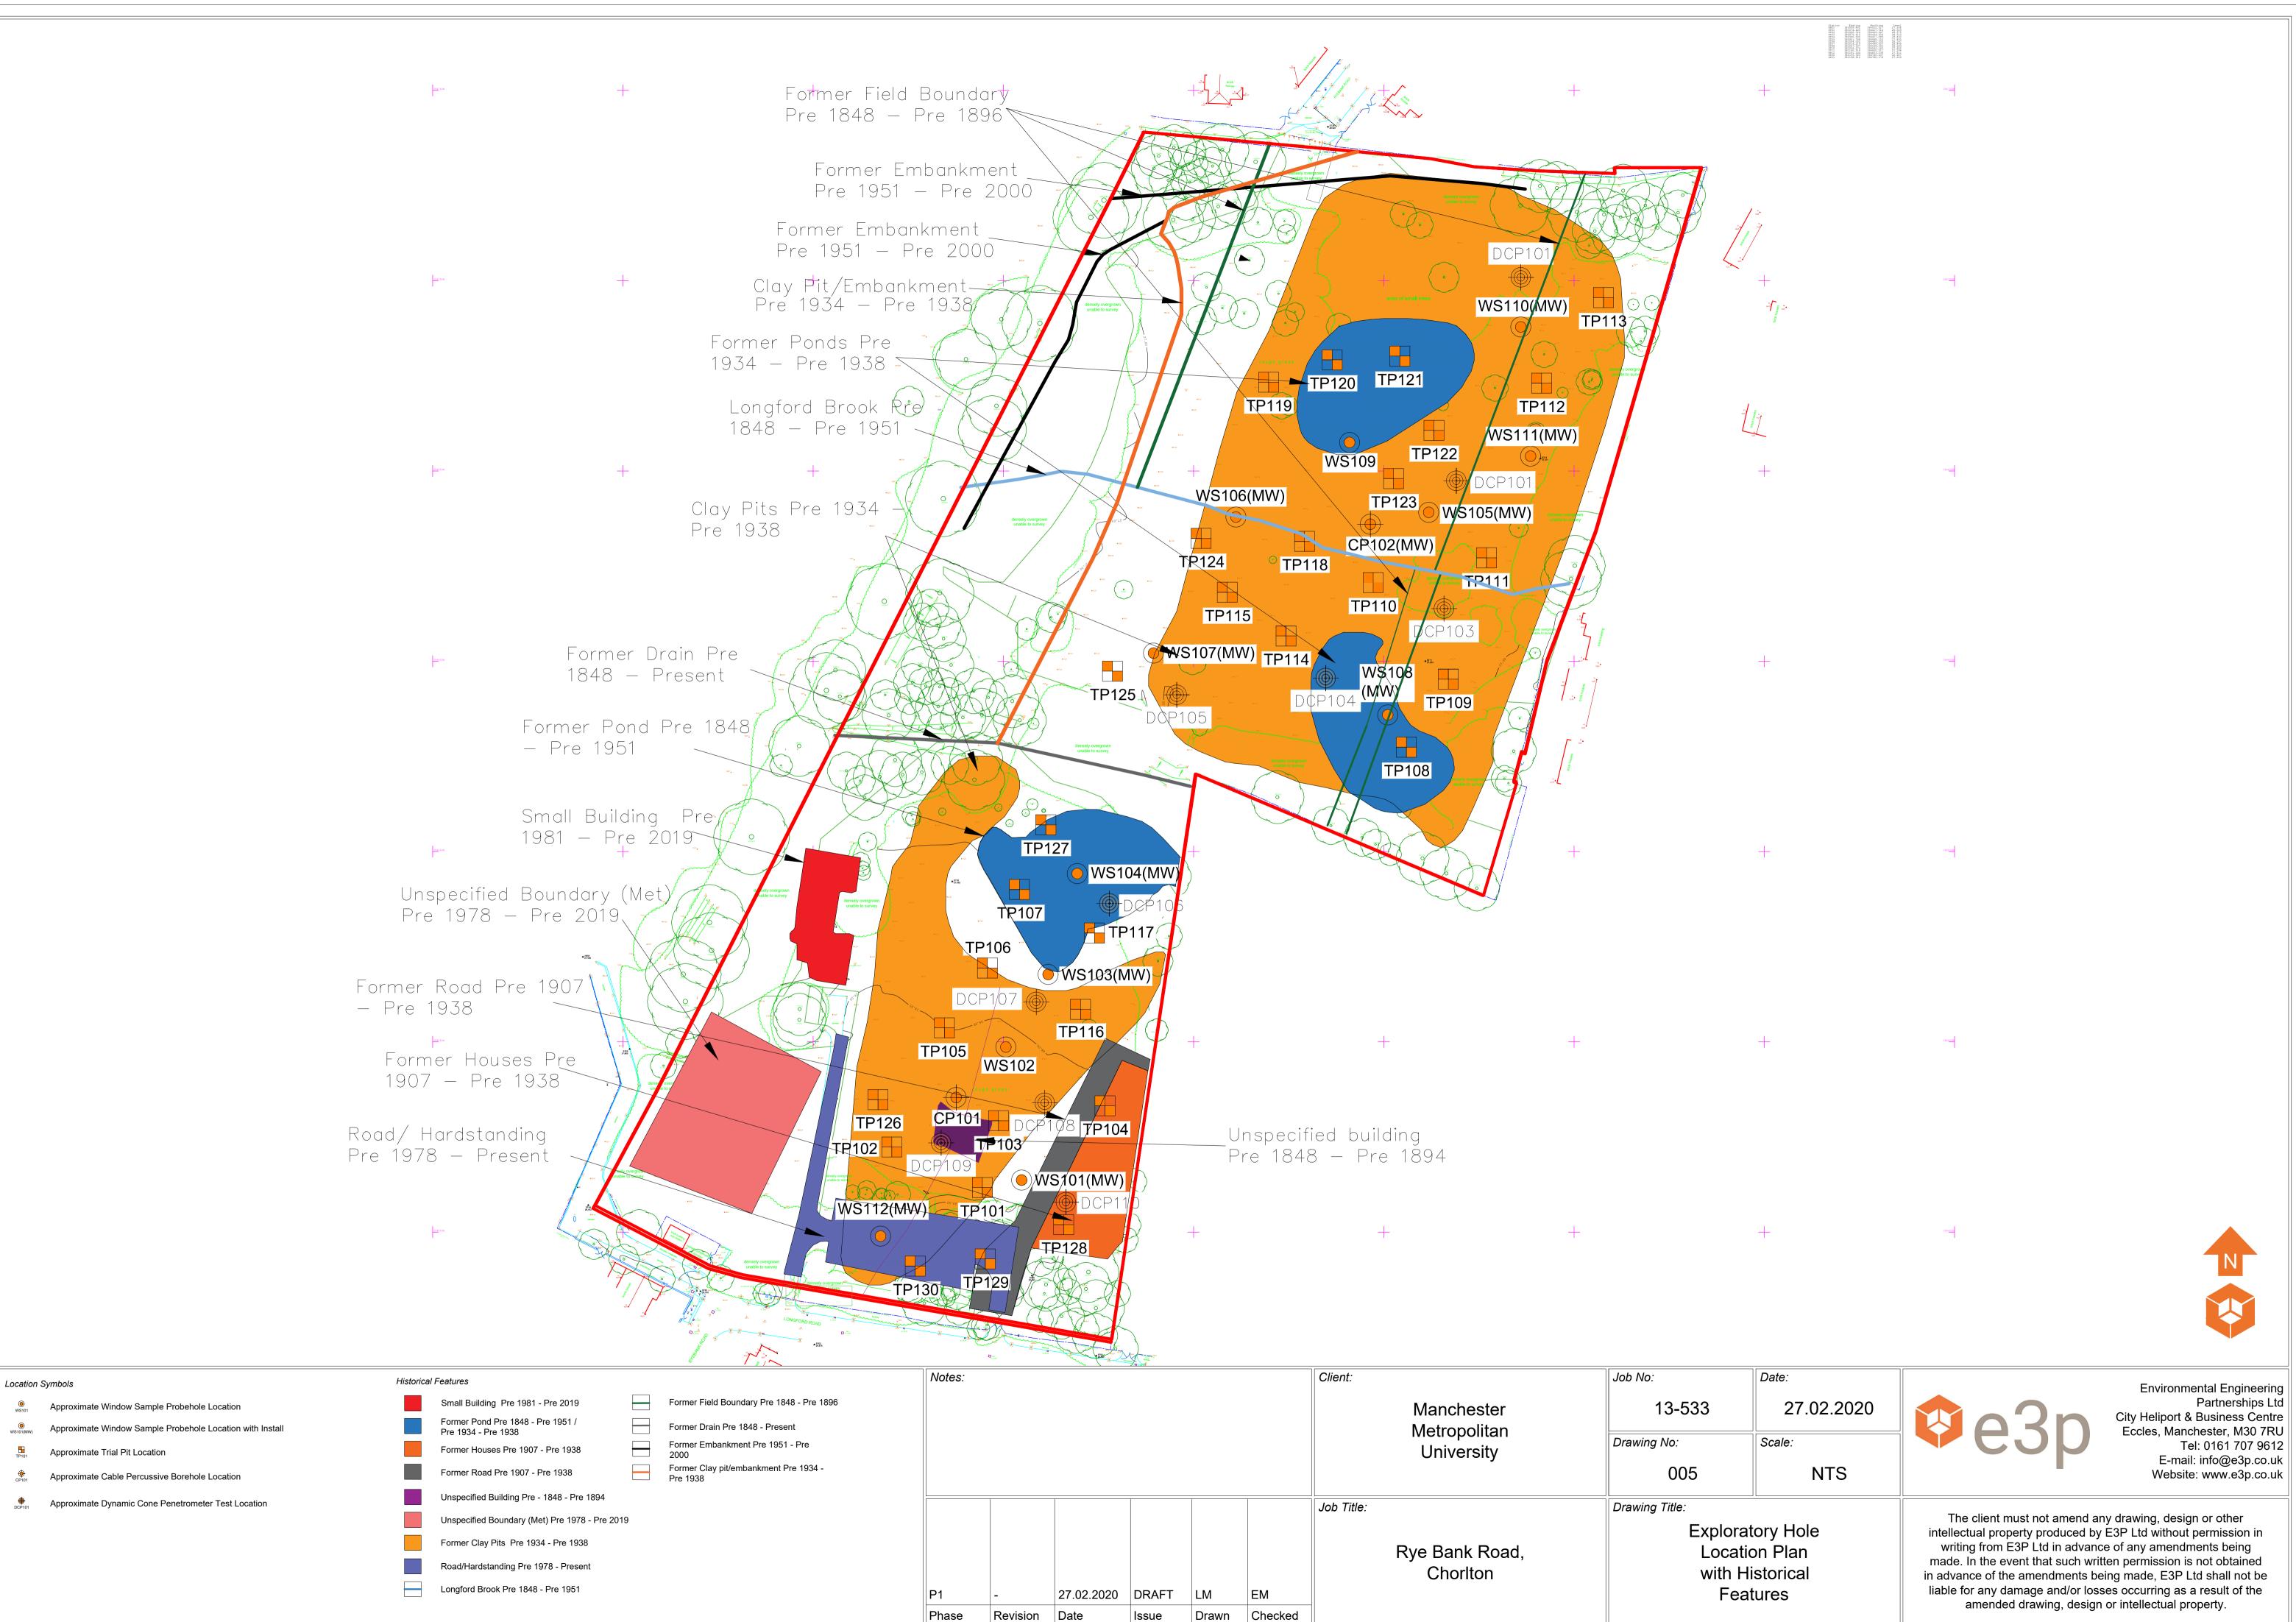
Small Building Pre 1981 - Pre 2019
Former Pond Pre 1848 - Pre 1951 / Pre 1934 - Pre 1938
Former Houses Pre 1907 - Pre 1938
Former Road Pre 1907 - Pre 1938
Unspecified Building Pre - 1848 - Pre 1894
Unspecified Boundary (Met) Pre 1978 - Pre 2019
Former Clay Pits Pre 1934 - Pre 1938

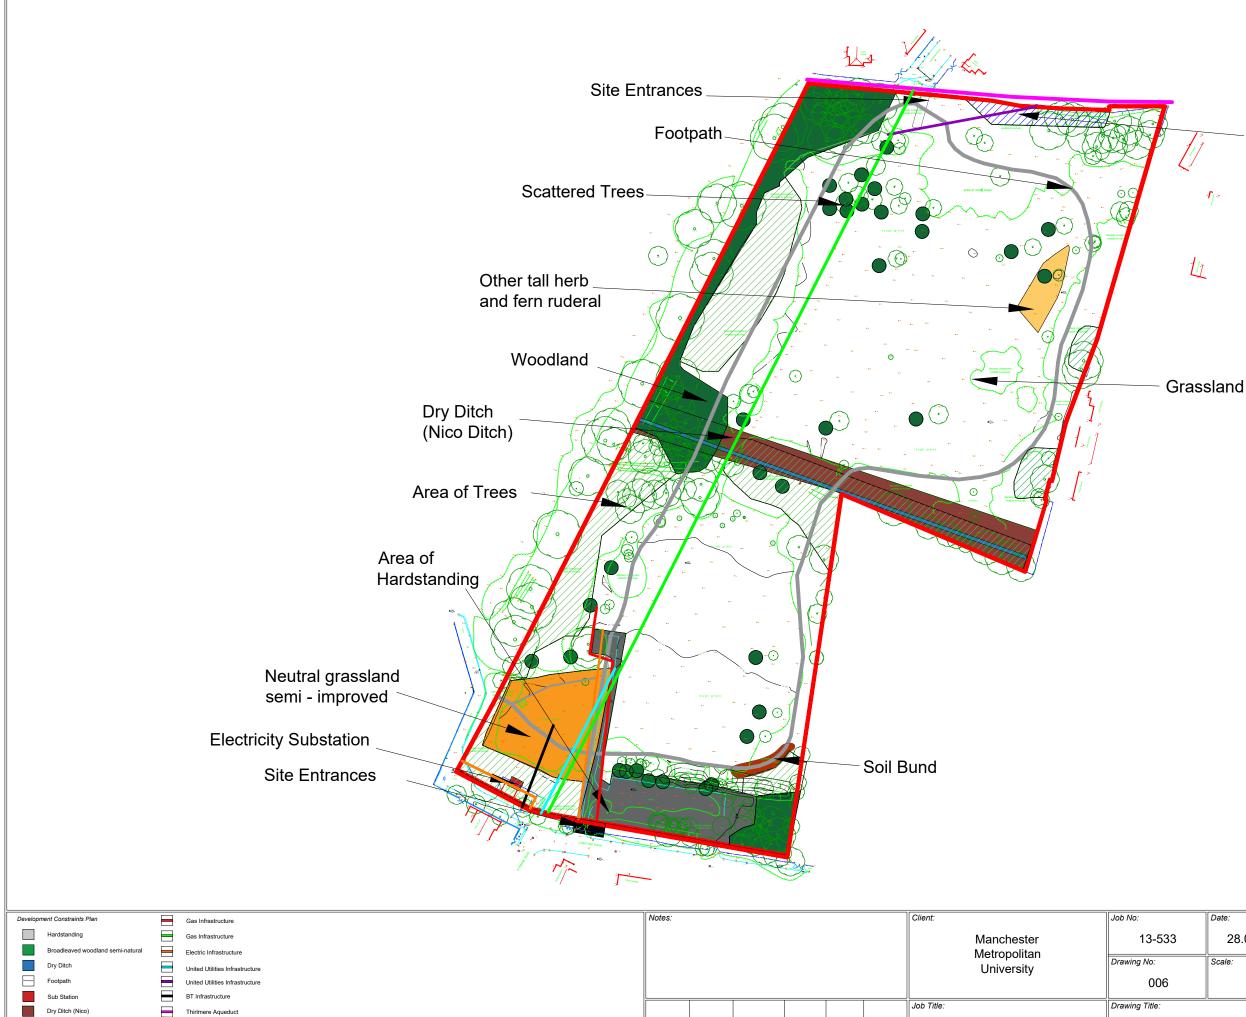
- () WS101(MW)
- TRIOI
- •
- DCP101

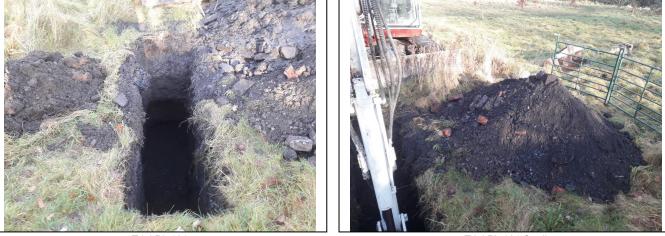
Trial Pit 101 Spoil

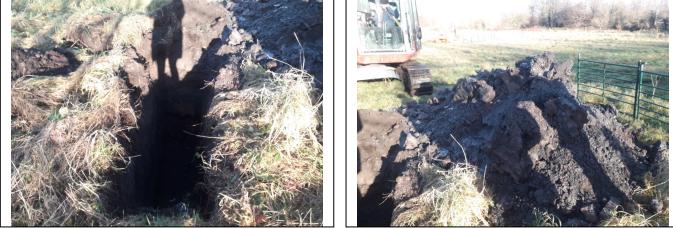
Trial Pit 102 Spoil Remarks: 1.Terminated at 2.30m bgl due to rapid groundwater ingress. 2.Rapid groundwater strike at 2.10m bgl.

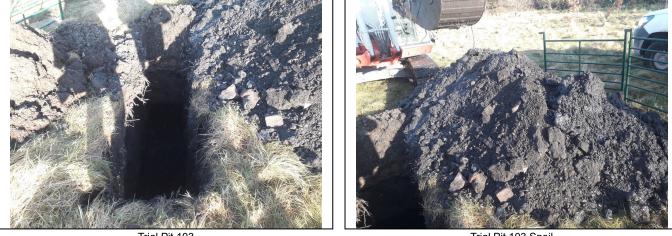
Trial Pit 103 Spoil Remarks: 1.Terminated at 2.40m bgl due to rapid groundwater ingress. 2.Rapid groundwater strike at 2.10m bgl.

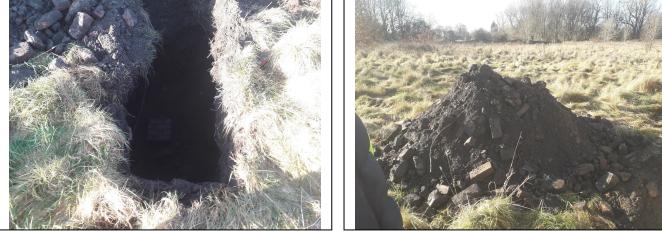
Trial Pit 110 Spoil

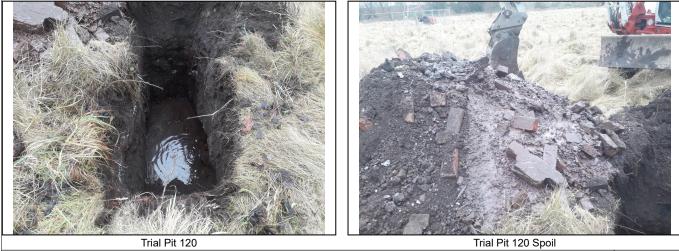
Remarks: 1.Terminated at 2.20m bgl due to rapid groundwater strike. 2.Rapid groundwater strike at 2.10m bgl. 3.Strong hydrocarbon odour at 2.10m bgl.

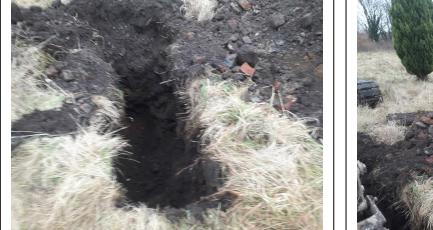
Trial Pit 122

2.90	1.00	ES		0.20			MADE GROUND: Brown slightly sandy g occasional cobbles and frequent rootlets Topsoil). Gravel is fine to coarse, sub-any rounded of sandstone, mudstone, concre Cobbles are sub-angular of concrete and MADE GROUND: Black gravelly coarse e with frequent cobbles and occasional bou is fine to coarse, sub-angular to sub-rour sandstone, ash, mudstone, concrete and Cobbles are sub-angular of brick. Boulde angular of concrete. (Concrete obstructio length).	(Reworked ular to sub- te and brick. brick. sand (ash) Ilders. Gravel ded of brick. s are sub-	2
