MANCHESTER METROPOLITAN UNIVERSITY

RYEBANK FIELDS

ARCHAEOLOGICAL DESK BASED ASSESSMENT/DUE DILIGENCE REPORT

JUNE 2020

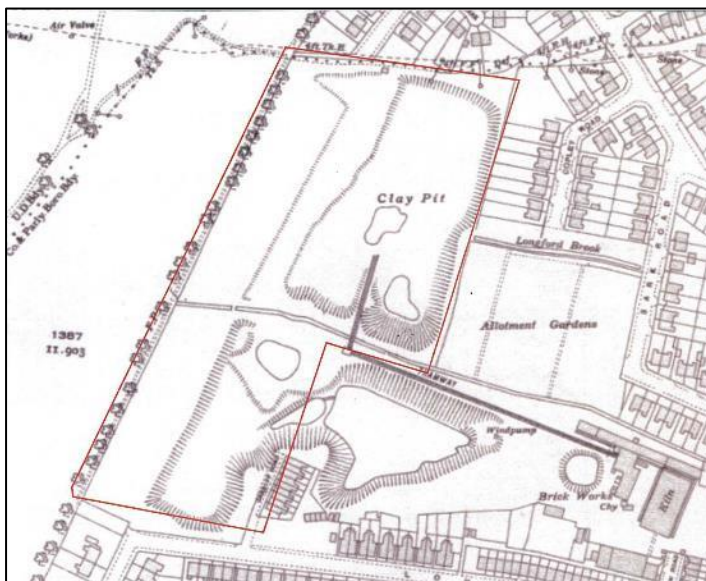
Plate 1: 1935 Ordnance Survey Map

- 2.4 The underlying solid geology is mapped as sandstone of the Wilmslow Sandstone Formation formed 247-252 million years ago. Superficial geology is mapped as Diamicton formed 2 million years ago (BGS 2019). This is known to have been exploited within the boundary of the Site through twentieth century clay extraction. This is shown by the depiction of clay pits across the majority of the Site on the 1935 Ordnance Survey map, see Plate 1.

- 2.5 Only the western fringe of the Site and footprint of the aforementioned ditch appear relatively unaffected by the clay extraction on this map. Later mapping dating to the 1950s indicates that the extraction may have extended further west towards the Site boundary.
- 2.6 Geotechnical investigations have verified the presence of a mantle of made ground across the Site as a consequence of infill post clay extraction operations (e3p 2020). Site investigations recorded made ground to depths of 1.6-12.7m across the body of the Site. The maximum depth of made ground was only verified by two boreholes which recorded that made ground extended to 10.2m and 12.7m in the north and south of the Site respectively. The made ground was recorded as sandy ashy gravel including asphalt, ash, concrete, brick, plastic, metal and glass.

- 2.38 On the 1935 map, the extant east-west ditch present across the centre of the Site appears to have been respected by the extraction activity; the pits apparently avoiding its alignment. However, the other wet ditch/watercourse shown on the earlier maps crossing the north of Site was impacted by the northern extraction area and observation of the 1951 Ordnance Survey appears to indicate that it was routed down the eastern boundary of the Site to drain into the extant east west ditch cut which was marked as a 'drain' by 1951.

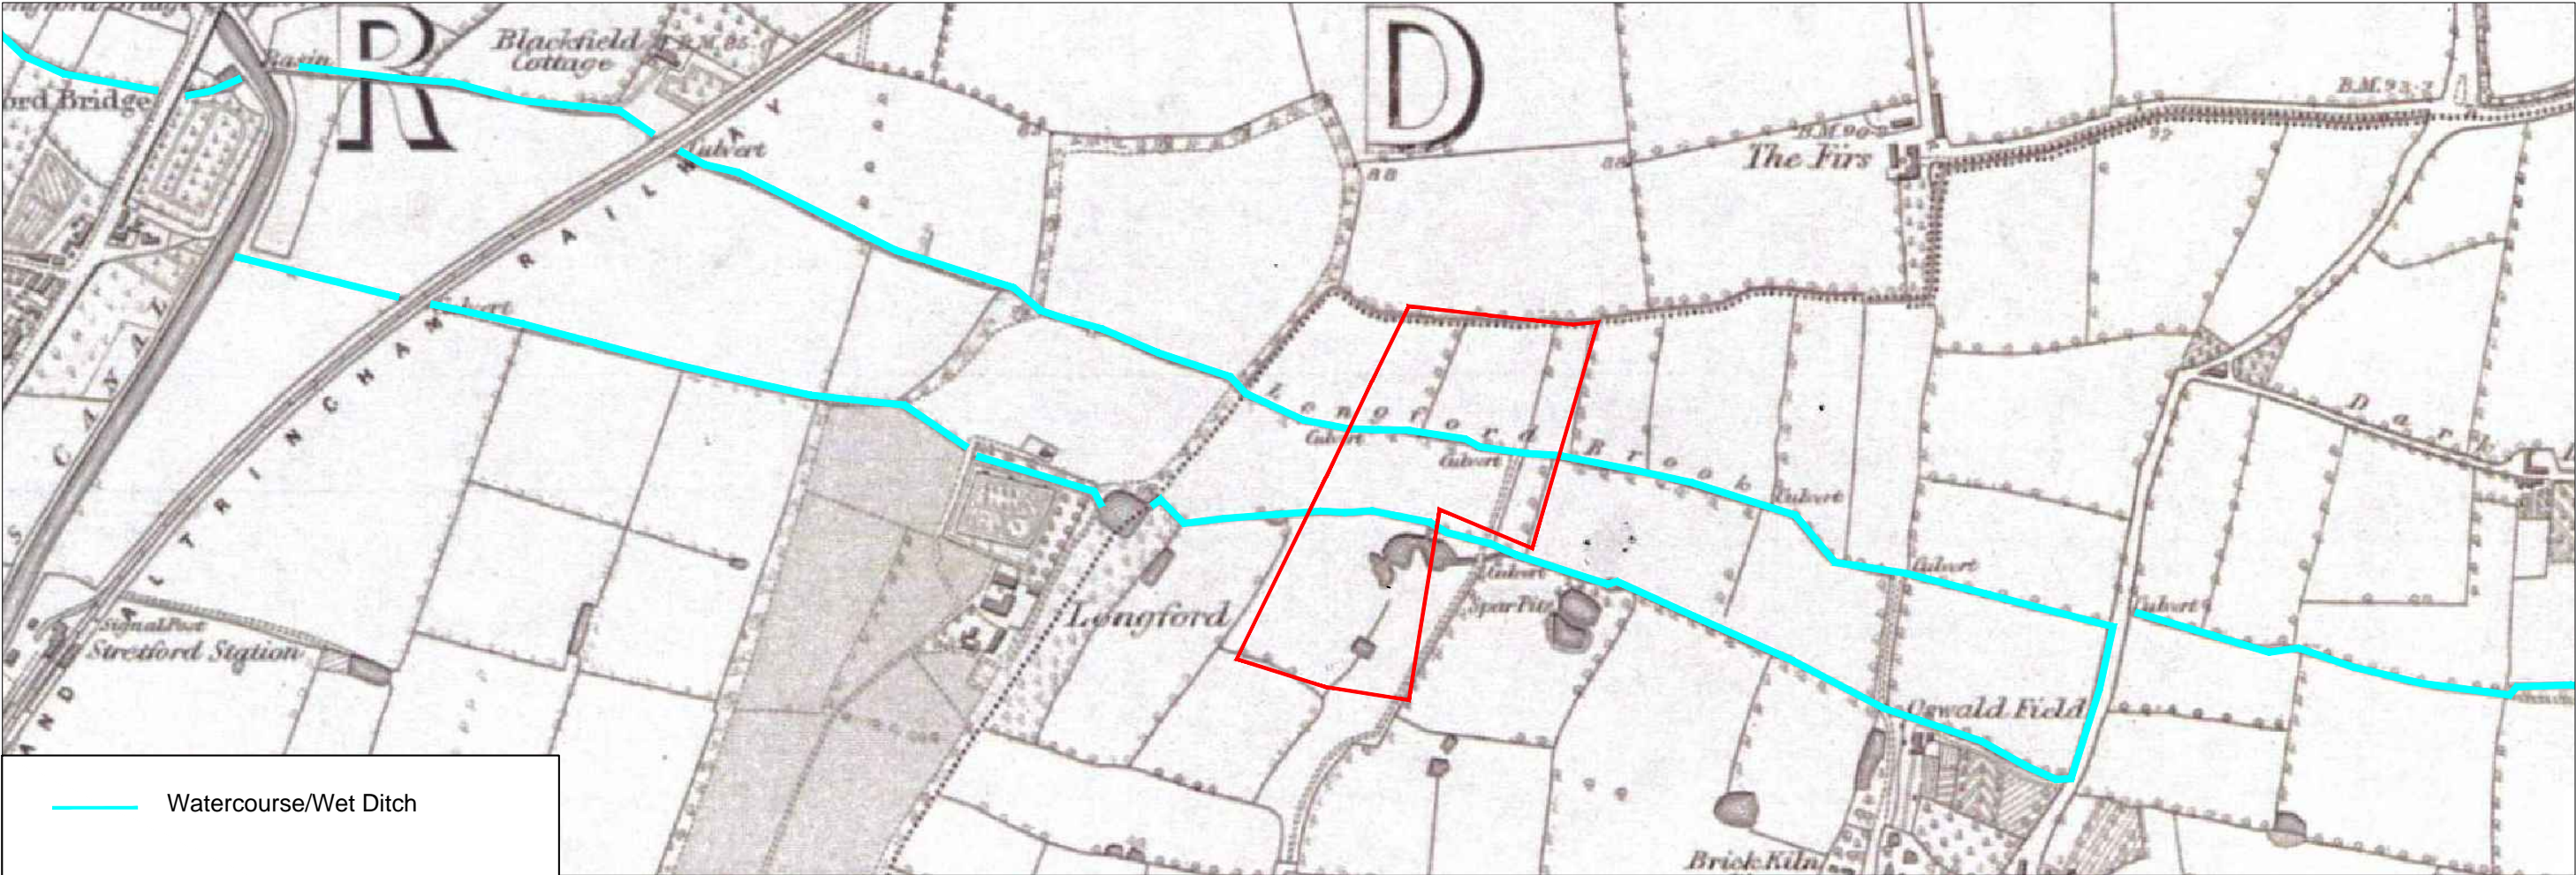
- 2.40 In respect to the wet ditches/watercourses crossing/formerly crossing the Site, observation of the earliest Ordnance Survey map dating to 1845 is useful to understand their relation to drainage network within the wider landscape before twentieth century interventions, see Appendix 2.

- 2.41 On the 1845 OS map the section of wet ditch/watercourse crossing the north of the Site is annotated as the 'Longford Brook', confirming its status as a watercourse. This extended across the landscape flowing west. The section of wet ditch across the centre of the Site, that which is extant within the Site today, was shown extending to the west where it terminated into the Bridgewater Canal. To the east it was shown to extend to Manchester Road where it was fed by a culvert off the Longford Brook.

- 2.42 Whilst this historic association with the Longford Brook as part of the canal feeder network may have been a relatively recent intervention evidenced by this map, its potential earlier association with the Nico ditch further to the east at Platt Fields is not obvious from this map. There is no obvious continuous alignment of field boundaries which could confirm this hypothesis that the Nico ditch extended to the Site.

- 2.43 Subsequent to the production of the 1845 Ordnance Survey map, the 1894 Ordnance Survey map shows the termination of the extant ditch at the western boundary of the Site and as stated above its use as a 'drain' off the Longford Brook is marked by 1951. In summary, the water management associated with the Longford Brook and the extant ditch cut appears to have evolved throughout the late nineteenth and twentieth century as the area became urbanised. The fragmentation of the Longford Brook and the termination of the extant ditch cut at the western boundary of the Site most likely being part of a wider drainage strategy implemented to improve ground conditions for residential development. A geo-environmental report for the Site prepared in 2015 referenced the extant ditch as being dry (WSP 2015).

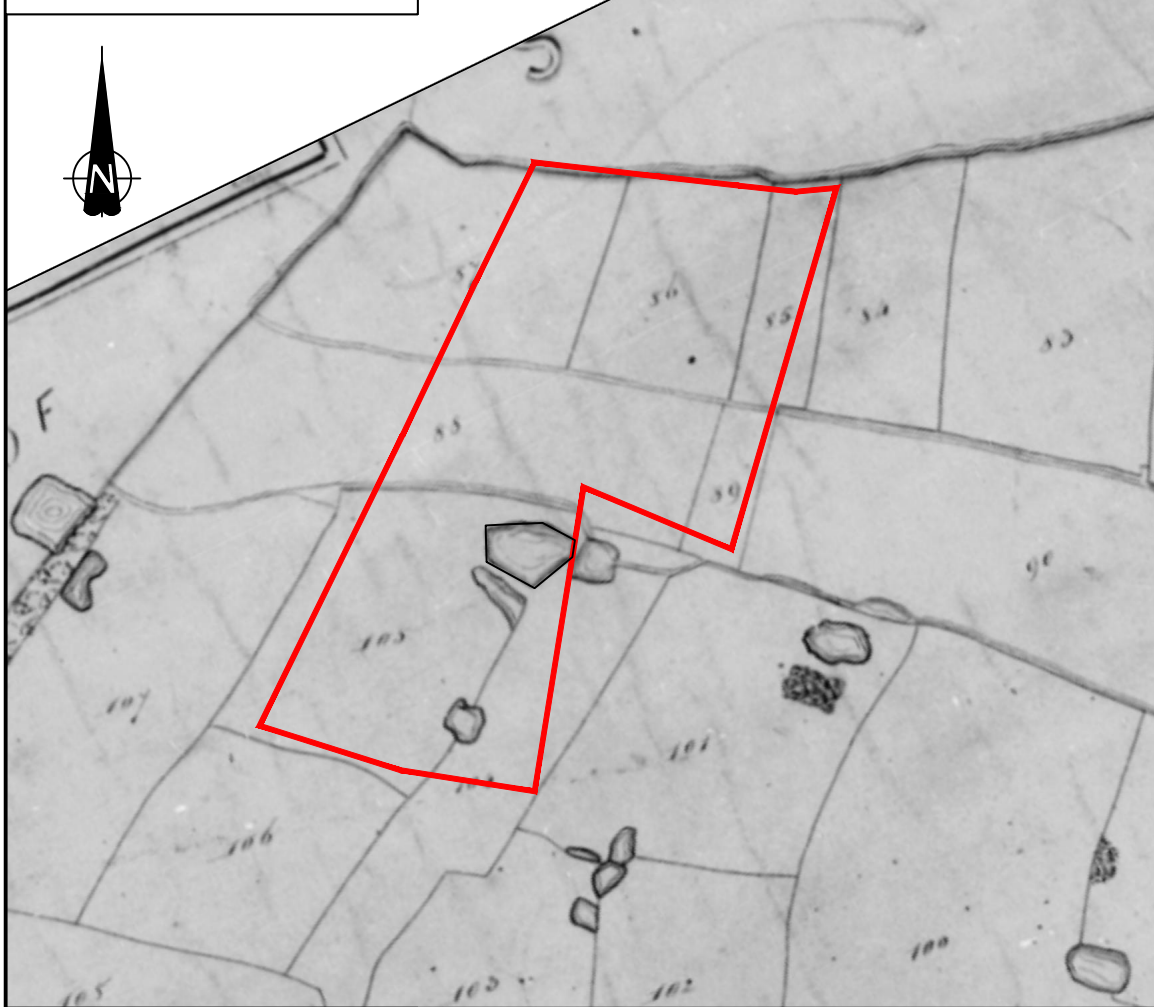
- 2.32 The late eighteenth century saw intensive drainage of the mosses such that arable production was made feasible through the use of extensive networks of ceramic drains and the deposition of sand, marl and nightsoil.
- 2.33 The earliest map observed as part of this assessment which showed the land within the boundary of the Site in detail was the 1845 Tithe Map for Chorlton cum Hardy, see Figure 2. This showed a number of roads converging on the village of Chorlton cum Hardy located c.1km south-east of the Site and set within a parish characterised by enclosed fields.
- 2.34 The fields around the village included a number under 'arable' use but the Site was located in the northern extremity of the parish in an area characterised by fields recorded as being under 'meadow' and 'pasture'. This area is noted to accord with an

- area of superficial geology recorded as including deposits of clay (Diamicton), a poor geology for arable use as attested by the prevalence of pasture and meadow within its footprint. A number of water features within the Site and its immediate vicinity are indicative of clay extraction either associated with localised small-scale industry (most likely brick-making) or indicative of the purposeful creation of watering holes for grazing livestock.

- 2.35 One of these features to the immediate east of the Site boundary appears to have been fed by a watercourse (or wet ditch) which extended into the Site according with the extant ditch cut which is present today. A further watercourse extended parallel to this through the north of the Site.

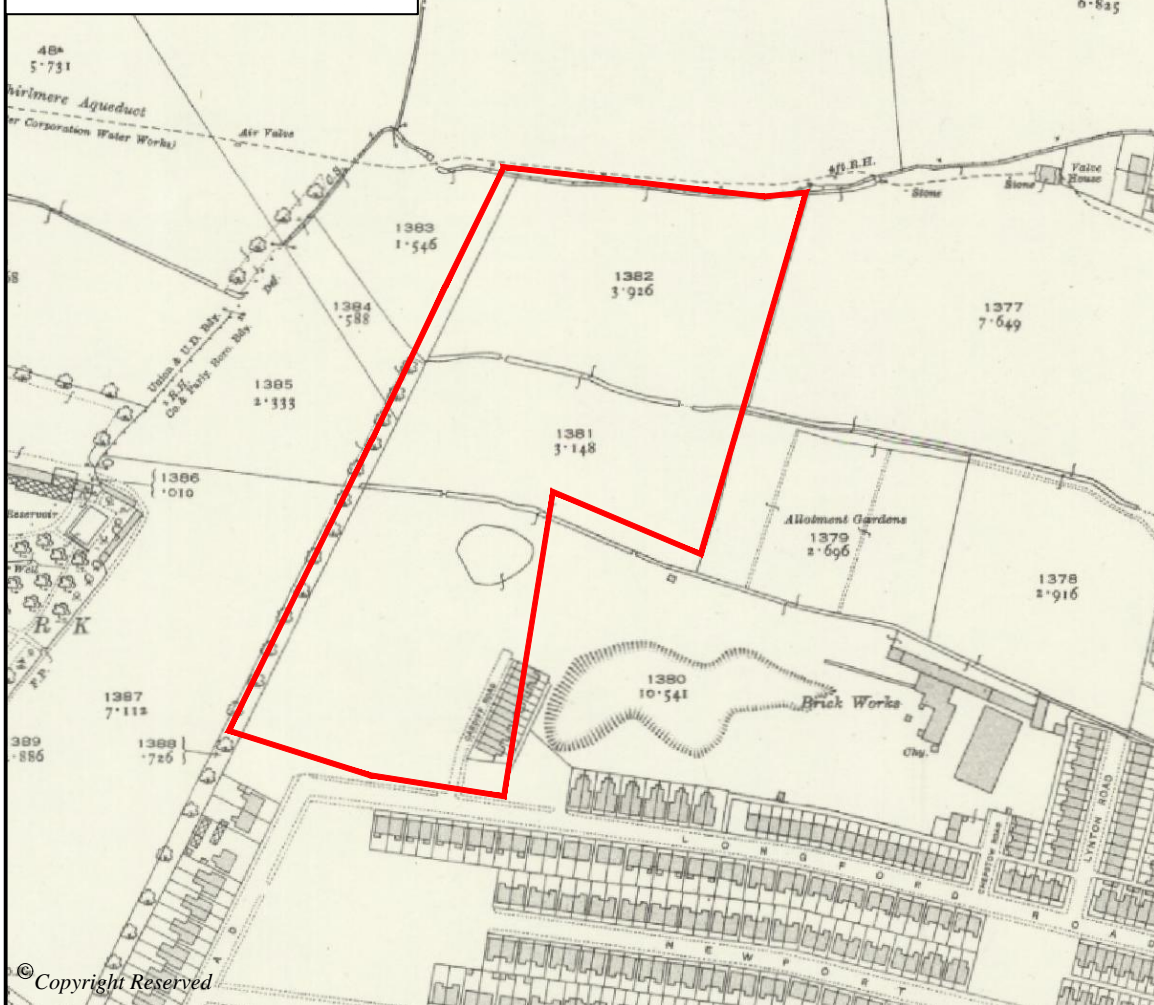
- 2.37 In accordance with this, the 1922 Ordnance Survey map depicts the presence of a 'Brick Works' to the east of the Site. This map also depicts urban sprawl to the fringes of the Site including a short row of terraces depicted within the Site boundary. Furthermore, the later 1935 map shows extensive clay extraction across the Site, the local reserves of clay being exploited on a larger industrial scale to support the 'Brick Works' to the east of the Site which continued to operate at this time.

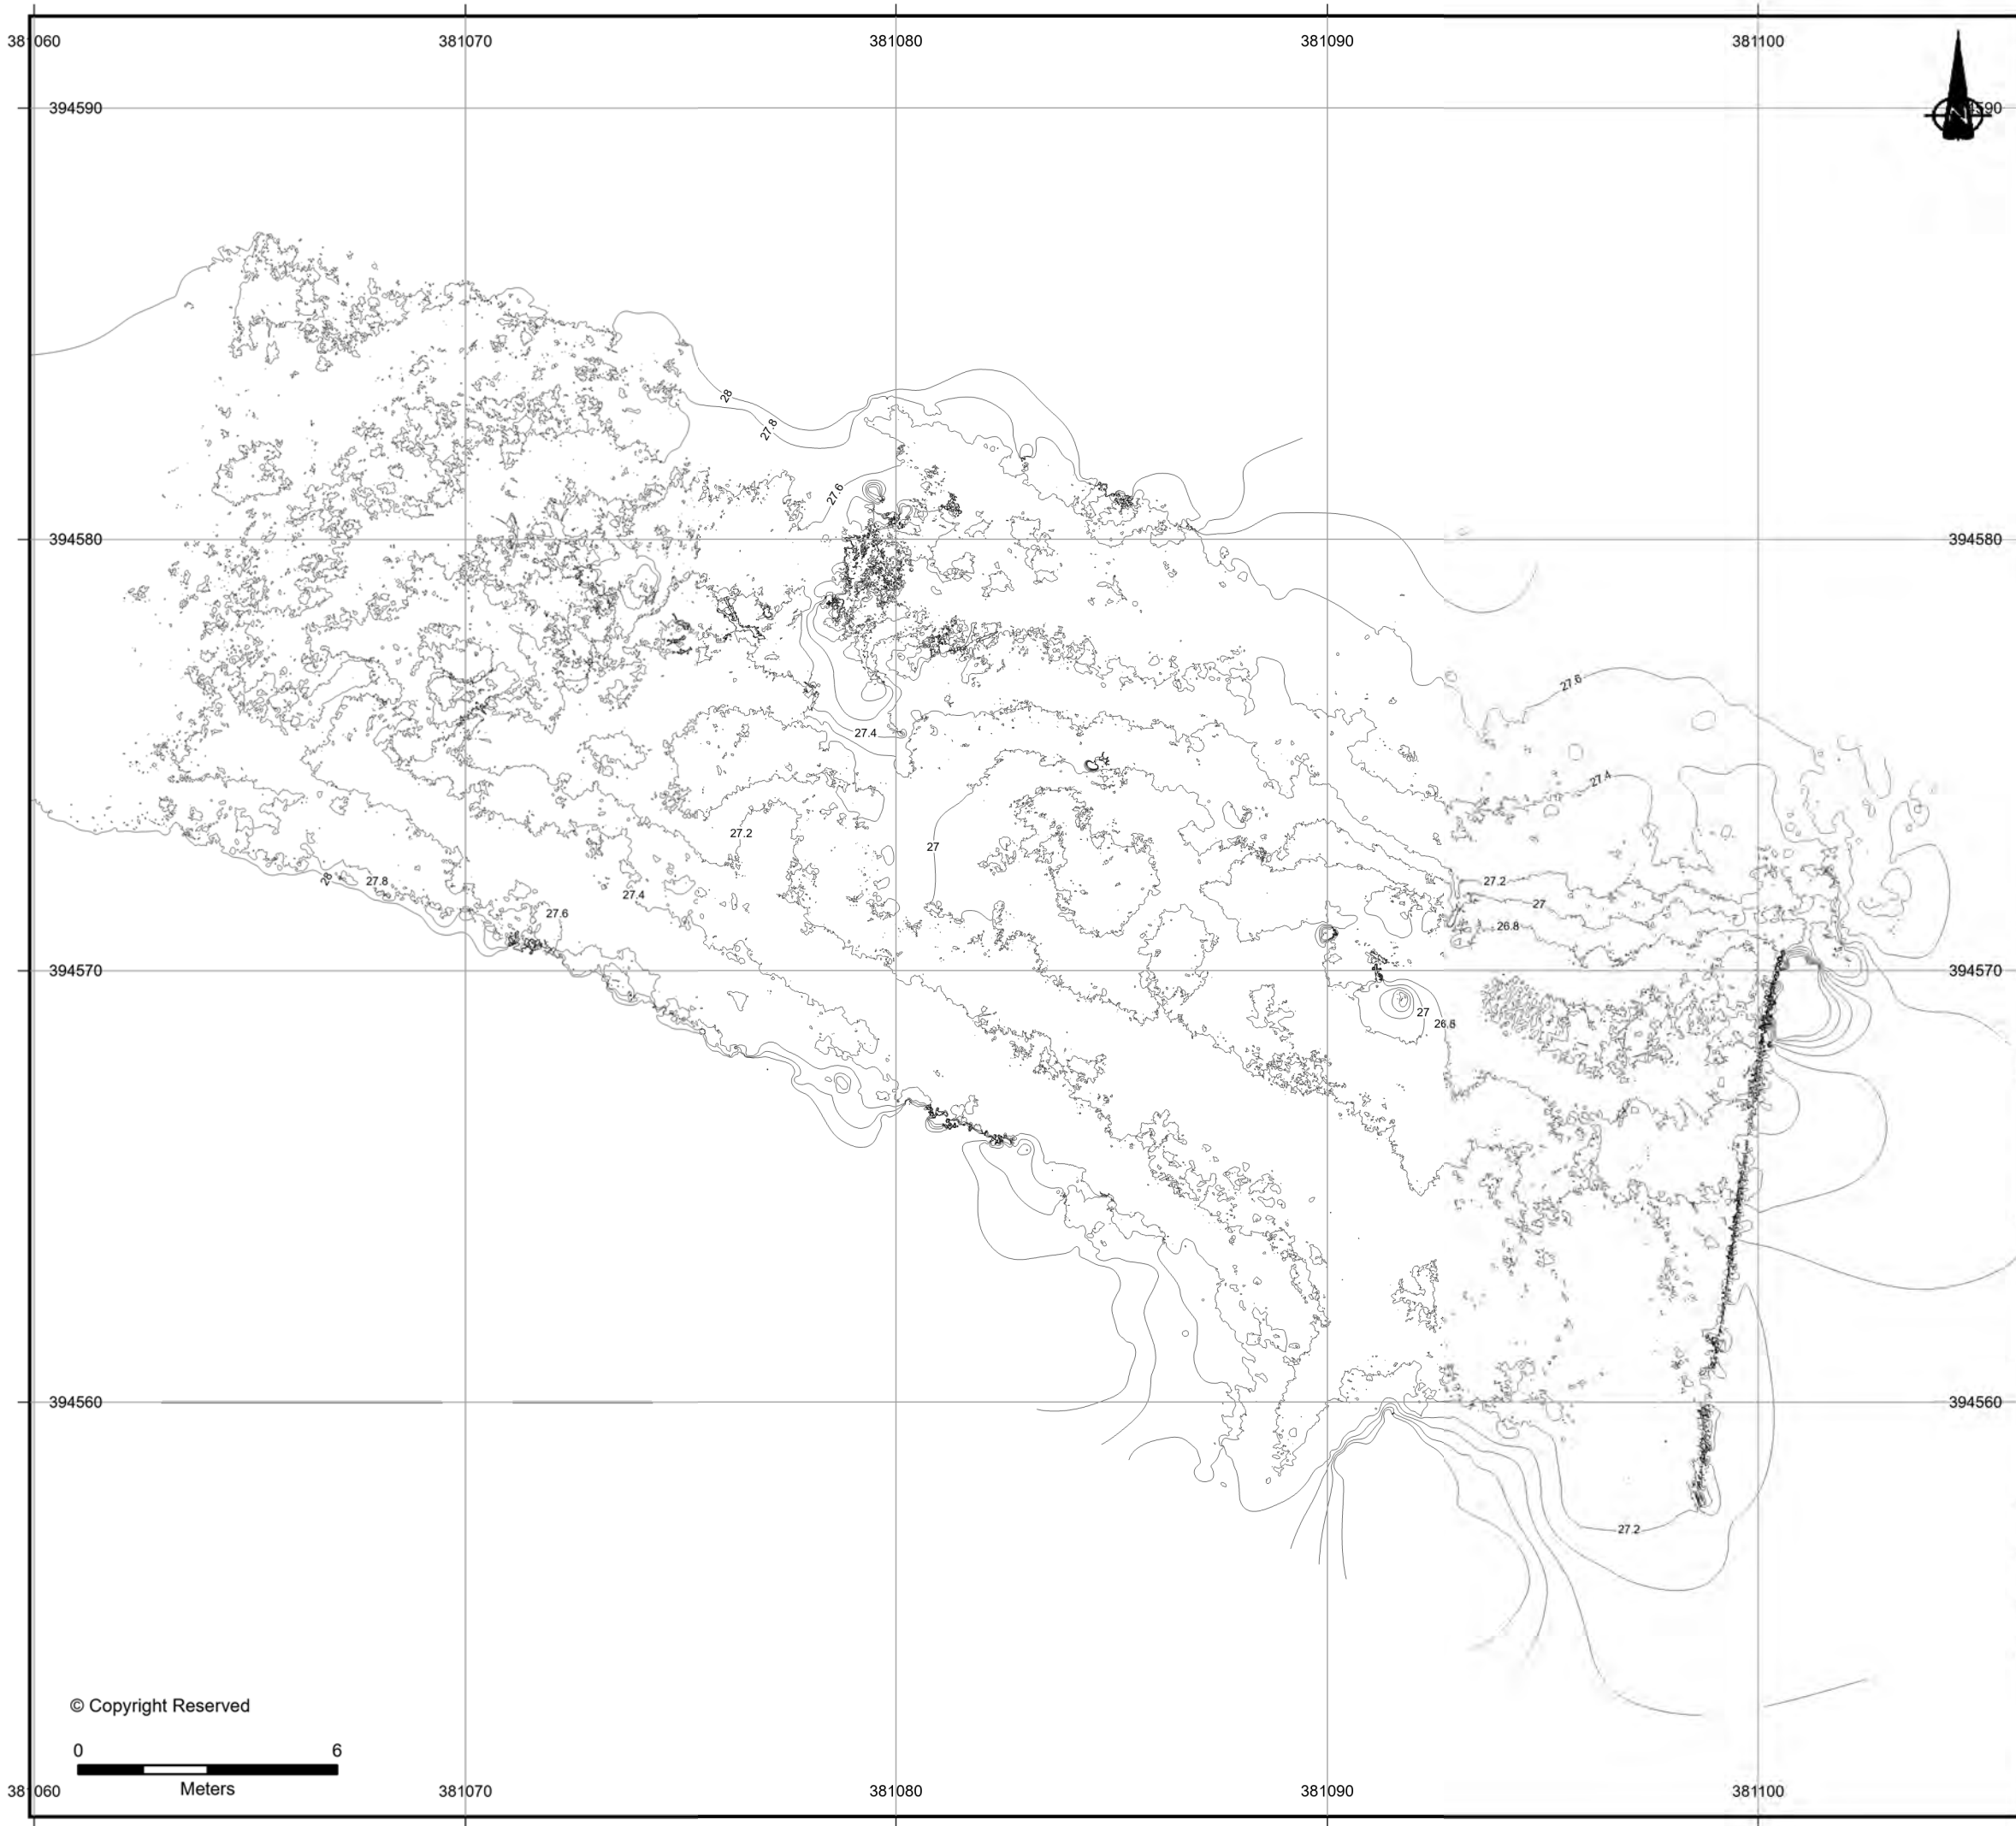
KEY
 — Contour lines (at 0.2m intervals)

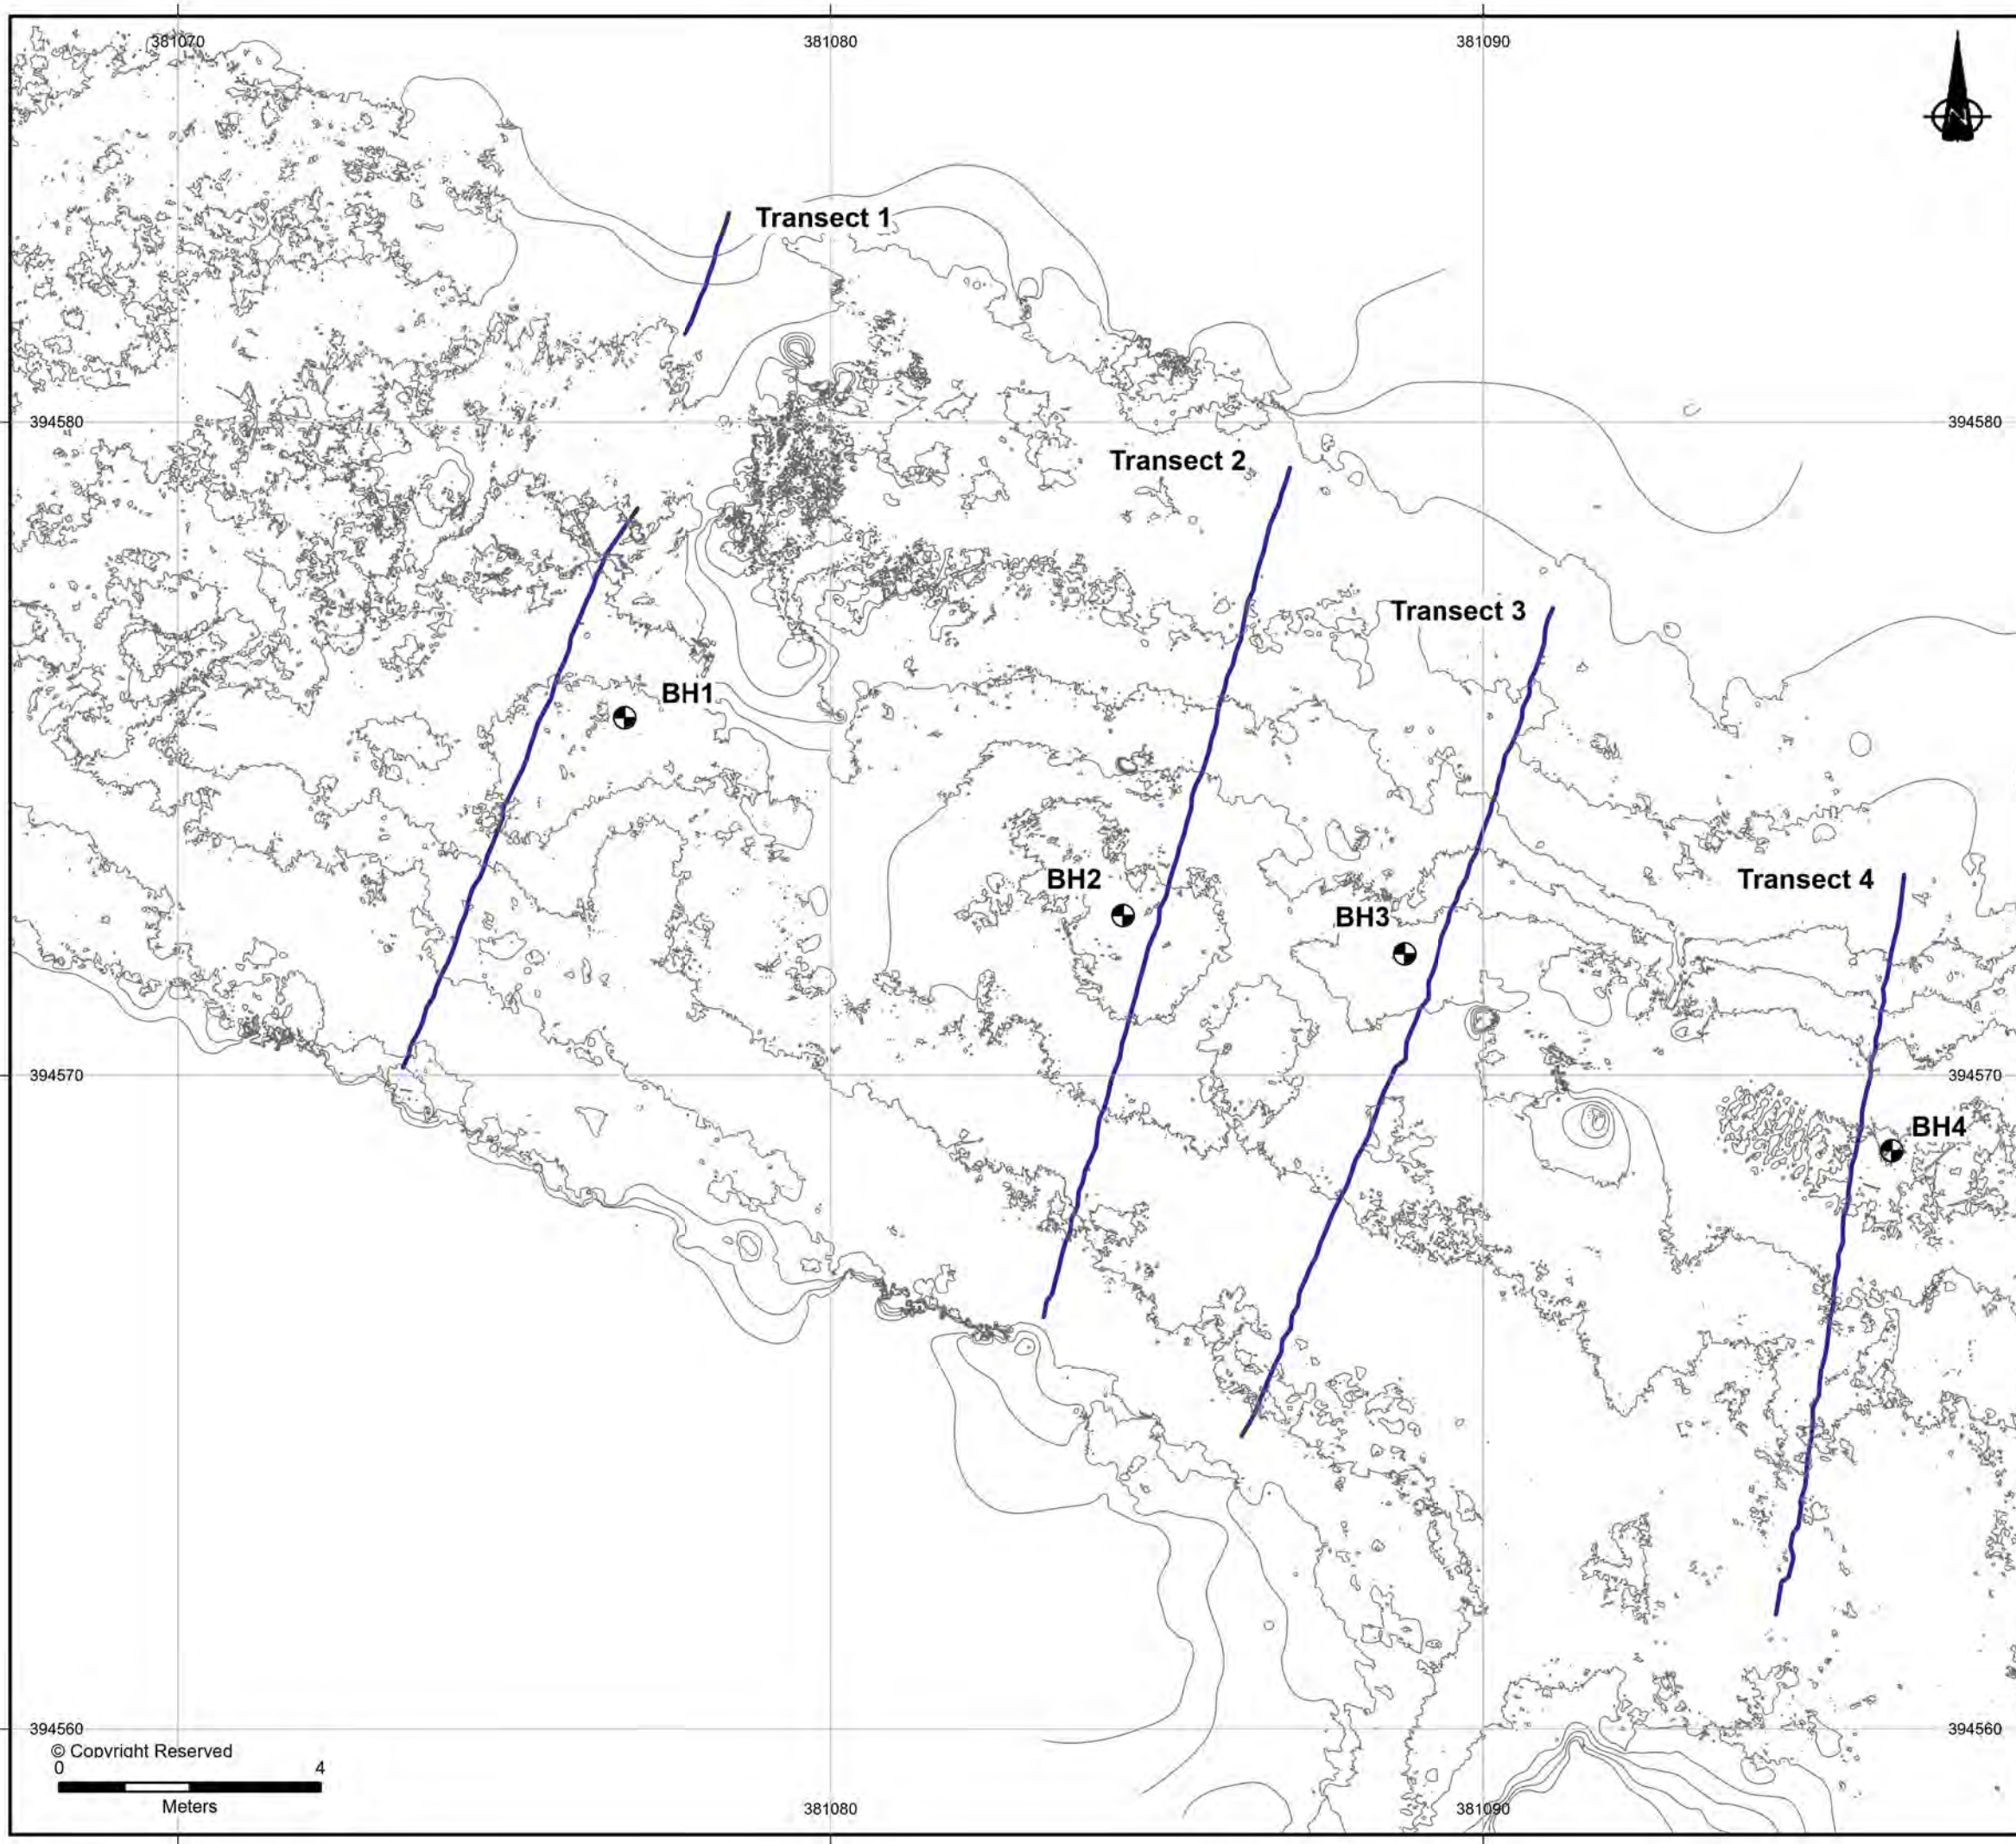
- Contour lines (at 0.2m intervals)
- Transects
- Boreholes

- 3.13 The upper ditch-fill was generally contiguous across all four transects, comprising organic material and rooting. The upper ditch-fill/ topsoil observed within boreholes one and two also contained modern waste material such as brick.
